HUTCHINSON ASBESTOS REMOVAL LTD

Please find enclosed the details for managing the identified asbestos containing materials within your property as detailed in our asbestos report.

**Baildon Mills,
Northgate,
Baildon,
Shipley,
West Yorkshire.
BD17 6JY**

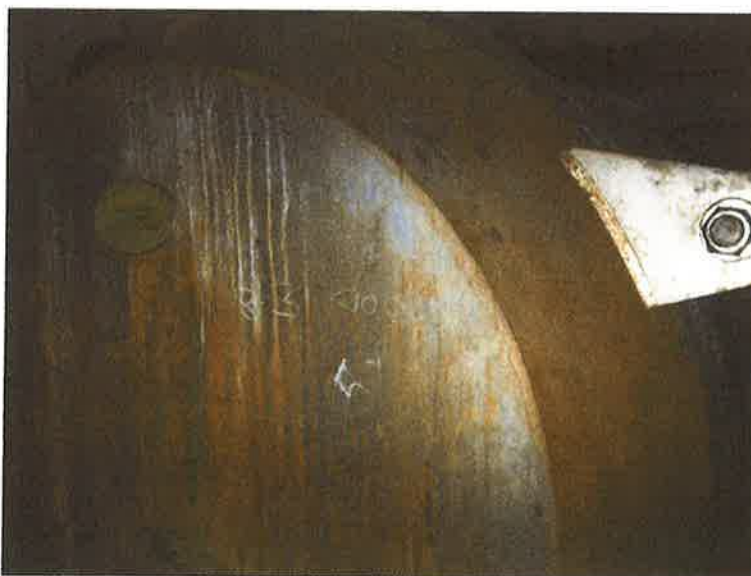
<u>SAMPLE REF.</u>	389	<u>SURVEY TYPE</u>	T2
<u>DATE TAKEN</u>	30/12/2004	<u>ASBESTOS TYPE</u>	Chrysotile
<u>AREA</u>	Boiler	<u>ANALYSIS</u>	Assumed Significant
<u>FLOOR</u>	Ground floor	<u>CONDITION</u>	Fair
<u>ROOM</u>	boiler room	<u>FRIABILITY</u>	Low
<u>COMPONENT</u>	Boiler	<u>POSITION</u>	Internal
<u>SURVEYOR</u>	Garrie Thomas & Dean Jepson	<u>TREATMENT</u>	Sealed
<u>LAB</u>	UKAS1689	<u>MATERIAL RISK</u>	6 (Very Low)
<u>NEXT INSPECTION</u>	June 2005	<u>PRIORITY RISK</u>	4 (Very Low)
<u>REMOVAL COST</u>	TBQ		
<u>ACTION</u>	Apply Warning Labels to outer case.

Could not gain access, Check at next service by competent person, apply a permit to work system until ACM's are confirmed/denied.

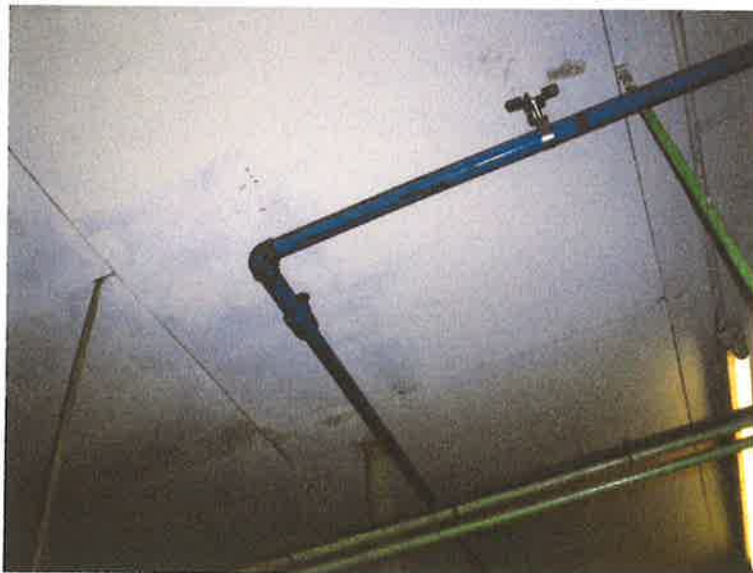
SAMPLE REF.	390	SURVEY TYPE	T2
DATE TAKEN	30/12/2004	ASBESTOS TYPE	
AREA	ceiling	ANALYSIS	NADIS
FLOOR	Ground floor	CONDITION	NADIS
ROOM	Boiler room	FRIABILITY	NADIS
COMPONENT	Cerment sheets	POSITION	NADIS
SURVEYOR	Garrie Thomas & Dean Jepson	TREATMENT	NADIS
LAB	UKAS1689	MATERIAL RISK	0 (NADIS)
NEXT INSPECTION	June 2005	PRIORITY RISK	0 (NFA)
REMOVAL COST	TBQ		
ACTION	Encapsulate and Apply Warning Labels

Check condition every 6 months and record. Replace when necessary and apply a permit to work system.

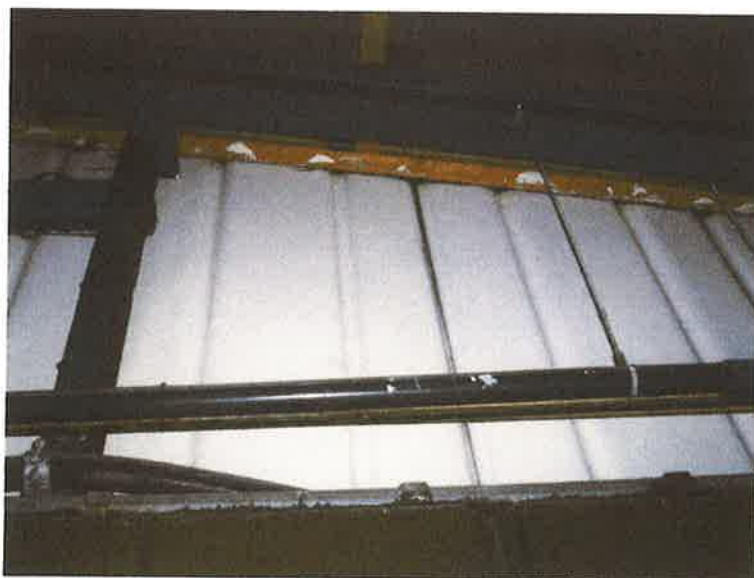
SAMPLE REF.	392	SURVEY TYPE	T2
DATE TAKEN	30/12/2004	ASBESTOS TYPE	Chrysotile
AREA	16	ANALYSIS	Low
FLOOR	Ground floor	CONDITION	Fair
ROOM	Dye house	FRIABILITY	Low
COMPONENT	Cerment profile	POSITION	External
SURVEYOR	Garrie Thomas & Dean Jepson	TREATMENT	Sealed
LAB	UKAS1689	MATERIAL RISK	3 (Very Low)
NEXT INSPECTION	June 2005	PRIORITY RISK	6 (Low)
REMOVAL COST	TBQ		
ACTION	Apply Warning Labels

Check condition every 6 months and record. Replace when necessary and apply a permit to work system.

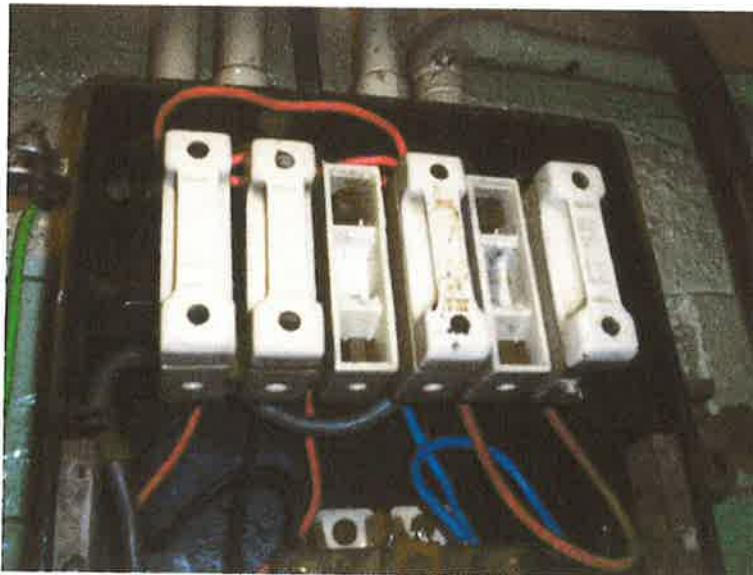
SAMPLE REF.	394	SURVEY TYPE	T2
DATE TAKEN	30/12/2004	ASBESTOS TYPE	Chrysotile
AREA	11	ANALYSIS	Significant
FLOOR	Ground floor	CONDITION	Fair
ROOM	Coridooor	FRIABILITY	High
COMPONENT	fuse cloth	POSITION	Internal
SURVEYOR	Garrie Thomas & Dean Jepson	TREATMENT	Unsealed
LAB	UKAS1689	MATERIAL RISK	14 (Medium)
NEXT INSPECTION	June 2005	PRIORITY RISK	4 (Very Low)
REMOVAL COST	TBQ		
ACTION	Apply Warning Labels to outer case.

Check condition every 6 months and record. Replace when necessary and apply a permit to work system.

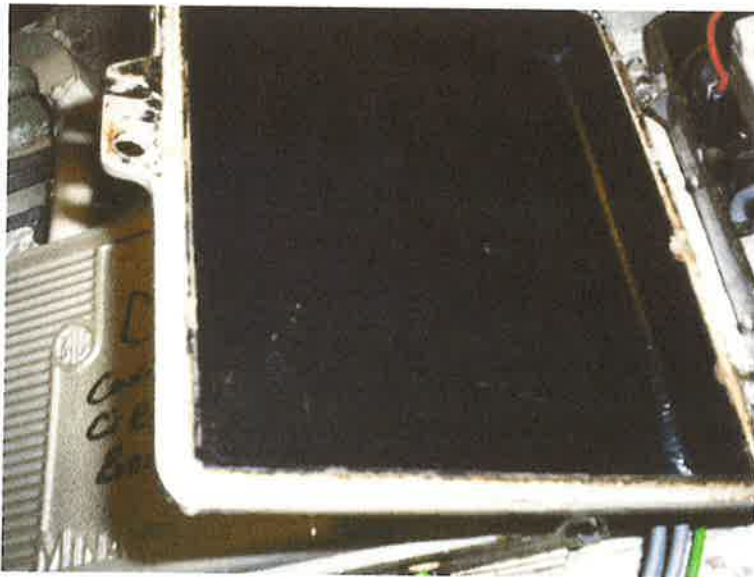
SAMPLE REF.	395	SURVEY TYPE	T2
DATE TAKEN	30/12/2004	ASBESTOS TYPE	Chrysotile
AREA	13	ANALYSIS	Significant
FLOOR	Ground floor	CONDITION	Fair
ROOM	Electric cupboard	FRIABILITY	High
COMPONENT	Fuse cloth door seal	POSITION	Internal
SURVEYOR	Garrie Thomas & Dean Jepson	TREATMENT	Unsealed
LAB	UKAS1689	MATERIAL RISK	14 (Medium)
NEXT INSPECTION	June 2005	PRIORITY RISK	4 (Very Low)
REMOVAL COST	TBQ		
ACTION	Apply Warning Labels to outer case.

Check condition every 6 months and record. Replace when necessary and apply a permit to work system.

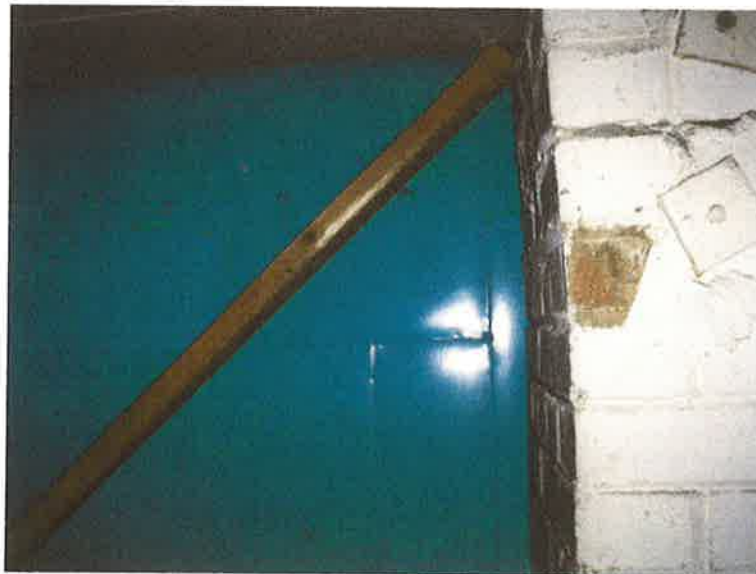
SAMPLE REF.	396	SURVEY TYPE	T2
DATE TAKEN	30/12/2004	ASBESTOS TYPE	Chrysotile
AREA	12	ANALYSIS	Assumed Significant
FLOOR	Ground floor	CONDITION	Fair
ROOM	unit room	FRIABILITY	Low
COMPONENT	Fire door	POSITION	Internal
SURVEYOR	Garrie Thomas & Dean Jepson	TREATMENT	Unsealed
LAB	UKAS1689	MATERIAL RISK	10 (Low)
NEXT INSPECTION	June 2005	PRIORITY RISK	3 (Very Low)
REMOVAL COST	TBQ		
ACTION	Apply Warning Labels to outer case.

Could not gain access, Check at next service by competent person, apply a permit to work system until ACM's are confirmed/denied.

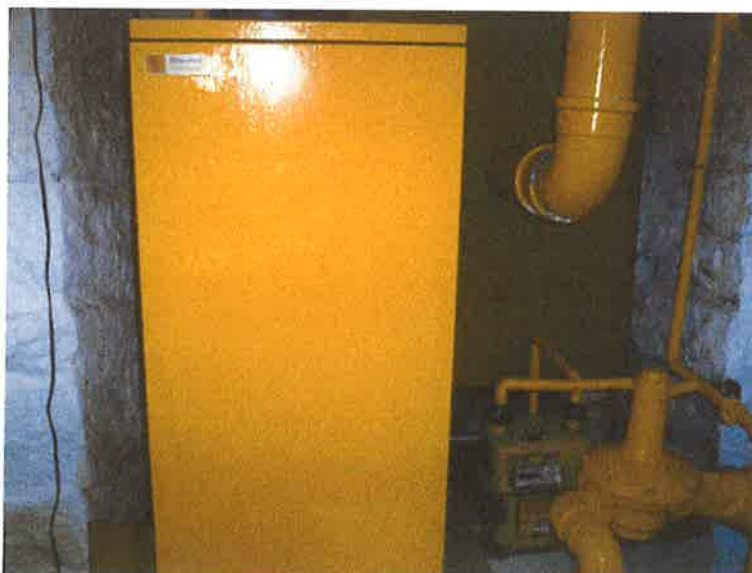
SAMPLE REF.	397	SURVEY TYPE	T2
DATE TAKEN	30/12/2004	ASBESTOS TYPE	Chrysotile
AREA	13	ANALYSIS	Assumed Significant
FLOOR	Ground floor	CONDITION	Fair
ROOM	S S Stores	FRIABILITY	Low
COMPONENT	Boiler	POSITION	Internal
SURVEYOR	Garrie Thomas & Dean Jepson	TREATMENT	Sealed
LAB	UKAS1689	MATERIAL RISK	6 (Very Low)
NEXT INSPECTION	June 2005	PRIORITY RISK	3 (Very Low)
REMOVAL COST	TBQ		
ACTION	Apply Warning Labels to outer case.

Could not gain access, Check at next service by competent person, apply a permit to work system until ACM's are confirmed/denied.

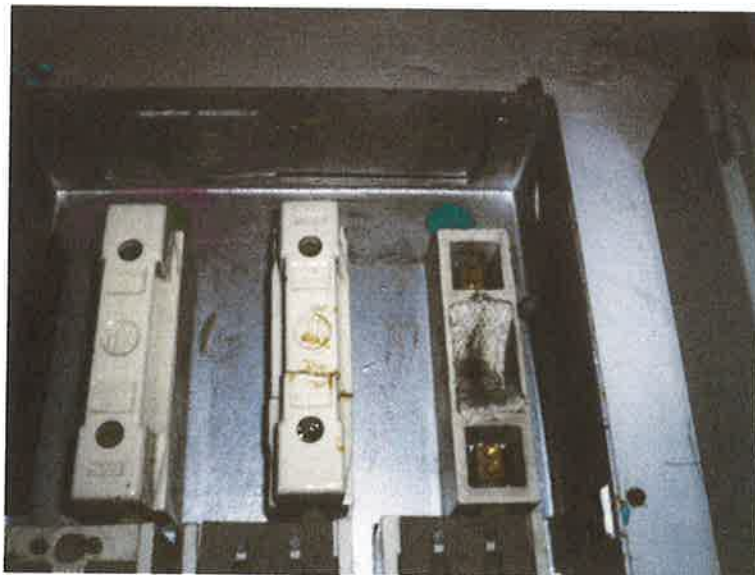
SAMPLE REF.	398	SURVEY TYPE	T2
DATE TAKEN	30/12/2004	ASBESTOS TYPE	Chrysotile
AREA	11	ANALYSIS	Significant
FLOOR	First floor	CONDITION	Fair
ROOM	Stores	FRIABILITY	High
COMPONENT	Fuse cloth & string x 3	POSITION	Internal
SURVEYOR	Garrie Thomas & Dean Jepson	TREATMENT	Unsealed
LAB	UKAS1689	MATERIAL RISK	14 (Medium)
NEXT INSPECTION	June 2005	PRIORITY RISK	2 (Very Low)
REMOVAL COST	TBQ		
ACTION	Apply Warning Labels to outer case.

Check condition every 6 months and record. Replace when necessary and apply a permit to work system.

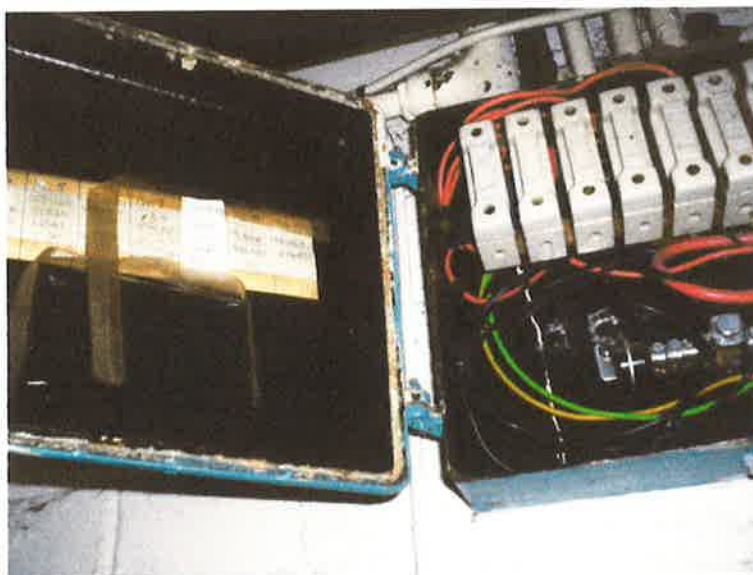
SAMPLE REF.	399	SURVEY TYPE	T2
DATE TAKEN	30/12/2004	ASBESTOS TYPE	Chrysotile
AREA	11 electrics	ANALYSIS	Significant
FLOOR	First floor	CONDITION	Fair
ROOM	Reception	FRIABILITY	High
COMPONENT	fuse cloth	POSITION	Internal
SURVEYOR	Garrie Thomas & Dean Jepson	TREATMENT	Unsealed
LAB	UKAS1689	MATERIAL RISK	14 (Medium)
NEXT INSPECTION	June 2005	PRIORITY RISK	4 (Very Low)
REMOVAL COST	TBQ		
ACTION	Apply Warning Labels to outer case.

Check condition every 6 months and record. Replace when necessary and apply a permit to work system.

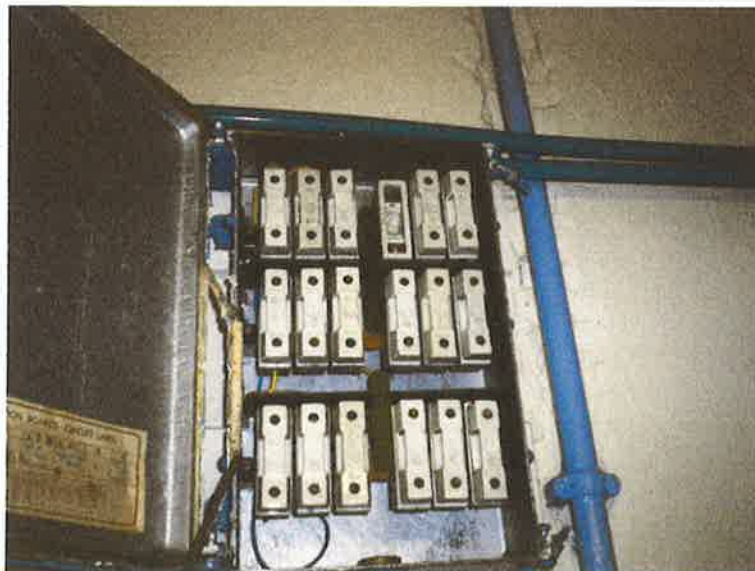
SAMPLE REF.	400	SURVEY TYPE	T2
DATE TAKEN	30/12/2004	ASBESTOS TYPE	Chrysotile
AREA	7	ANALYSIS	Significant
FLOOR	Ground floor	CONDITION	Fair
ROOM	Work shop	FRIABILITY	High
COMPONENT	Fuse cloth x 2	POSITION	Internal
SURVEYOR	Garrie Thomas & Dean Jepson	TREATMENT	Unsealed
LAB	UKAS1689	MATERIAL RISK	14 (Medium)
NEXT INSPECTION	June 2005	PRIORITY RISK	4 (Very Low)
REMOVAL COST	TBQ		
ACTION	Apply Warning Labels to outer case.

Check condition every 6 months and record. Replace when necessary and apply a permit to work system.

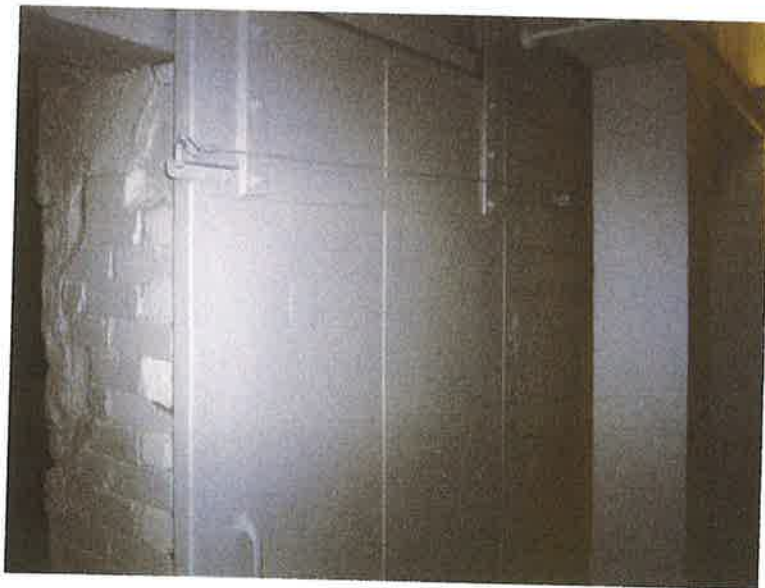
<u>SAMPLE REF.</u> 401	<u>SURVEY TYPE</u> T2
<u>DATE TAKEN</u> 30/12/2004	<u>ASBESTOS TYPE</u> Chrysotile
<u>AREA</u> 1	<u>ANALYSIS</u> Significant
<u>FLOOR</u> First floor	<u>CONDITION</u> Fair
<u>ROOM</u> Coridor	<u>FRIABILITY</u> Low
<u>COMPONENT</u> Fire doorx 2	<u>POSITION</u> Internal
<u>SURVEYOR</u> Garrie Thomas & Dean Jepson	<u>TREATMENT</u> Sealed
<u>LAB</u> UKAS1689	<u>MATERIAL RISK</u> 6 (Very Low)
<u>NEXT INSPECTION</u> June 2005	<u>PRIORITY RISK</u> 3 (Very Low)
<u>REMOVAL COST</u> TBQ	
<u>ACTION</u> Apply Warning Labels to outer case.

Could not gain access, Check at next service by competent person, apply a permit to work system until ACM's are confirmed/denied.

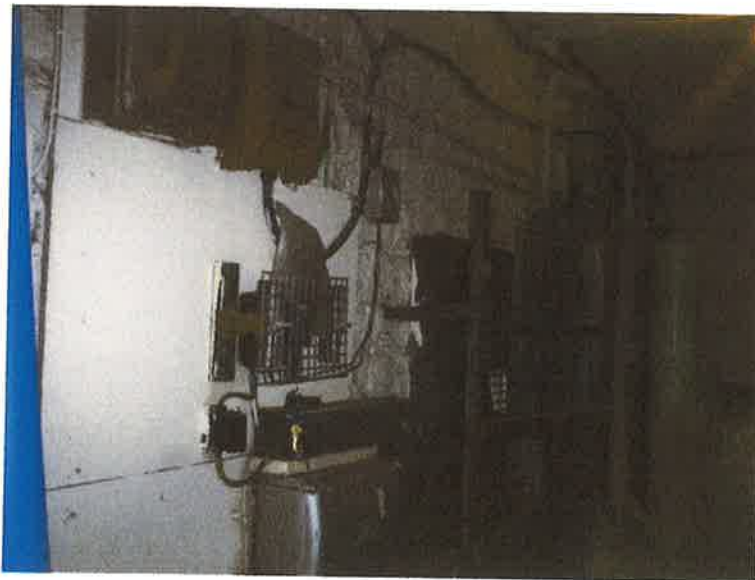
SAMPLE REF. 402	SURVEY TYPE T2
DATE TAKEN 30/12/2004	ASBESTOS TYPE Chrysotile
AREA 2	ANALYSIS Assumed Significant
FLOOR Ground floor	CONDITION Fair
ROOM Warehouse	FRIABILITY High
COMPONENT Electric boards	POSITION Internal
SURVEYOR Garrie Thomas & Dean Jepson	TREATMENT Unsealed
LAB UKAS1689	MATERIAL RISK 14 (Medium)
NEXT INSPECTION June 2005	PRIORITY RISK 4 (Very Low)
REMOVAL COST TBQ	
ACTION Apply Warning Labels to outer case.

Could not gain access, Check at next service by competent person, apply a permit to work system until ACM's are confirmed/denied.

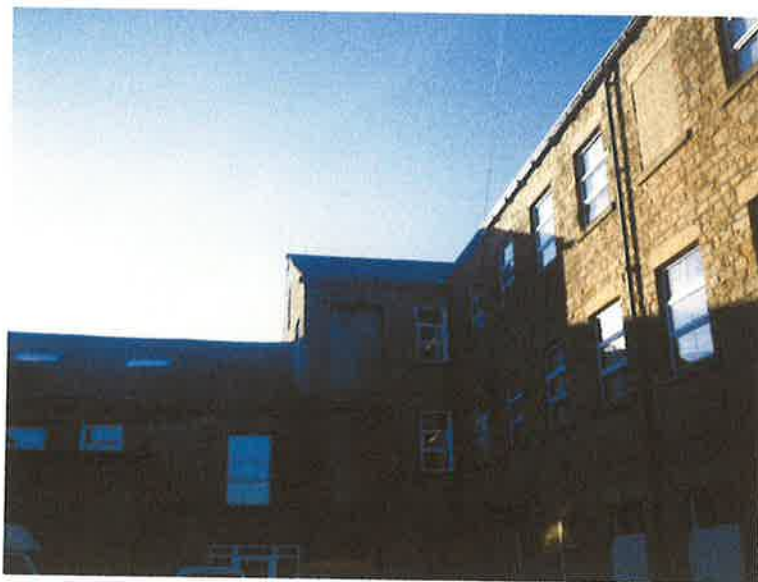
SAMPLE REF.	403	SURVEY TYPE	T2
DATE TAKEN	30/12/2004	ASBESTOS TYPE	Chrysotile
AREA	3/4/2/1	ANALYSIS	Low
FLOOR	External	CONDITION	Fair
ROOM	External	FRIABILITY	Low
COMPONENT	Profile/ridges & cement sheets	POSITION	External
SURVEYOR	Garrie Thomas & Dean Jepson	TREATMENT	Sealed
LAB	UKAS1689	MATERIAL RISK	3 (Very Low)
NEXT INSPECTION	June 2005	PRIORITY RISK	3 (Very Low)
REMOVAL COST	TBQ		
ACTION	Apply warning lables to underside

Check condition every 6 months and record. Re-encapsulate/ repair or replace when broken. Apply a permit to work system.
