HUTCHINSON ASBESTOS REMOVAL LTD

**Baildon Mills,
Northgate,
Baildon,
Shipley,
West Yorkshire.
BD17 6JY**

Surveyed by Garrie Thomas & Dean Jepson

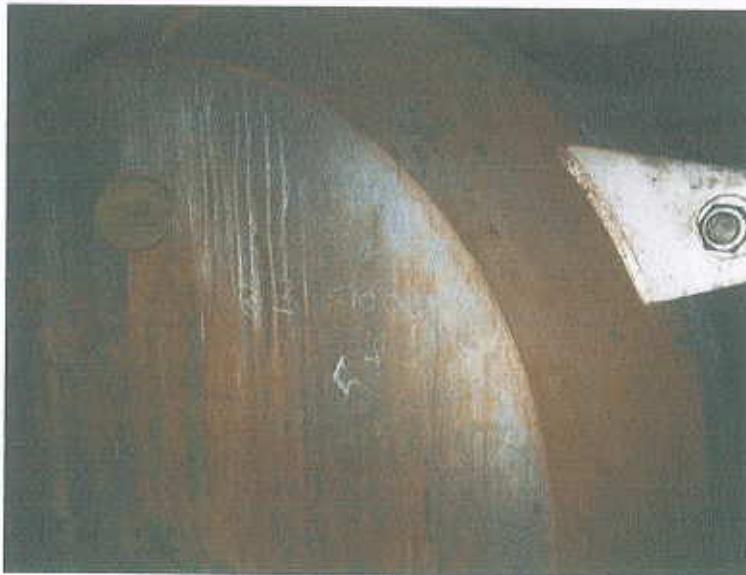
CLIENT	John Peel & Son Ltd	SITE	Baildon Mills, Northgate, Baildon, Shipley, West Yorkshire. BD17 6JY
SAMPLE REF.	389	SURVEY TYPE	T2
DATE TAKEN	30/12/2004	ASBESTOS TYPE	Chrysotile
AREA	Boiler	ANALYSIS	Assumed Significant
FLOOR	Ground floor	CONDITION	Fair
ROOM	boiler room	FRIABILITY	Low
COMPONENT	Boiler	POSITION	Internal
SURVEYOR	Garrie Thomas & Dean Jepson	TREATMENT	Sealed
LAB	UKAS1689	MATERIAL RISK	6 (Very Low)
NEXT INSPECTION	June 2005	PRIORITY RISK	4 (Very Low)
REMOVAL COST	TBQ		
ACTION	Apply Warning Labels to outer case.

Could not gain access, Check at next service by competent person, apply a permit to work system until ACM's are confirmed/denied.

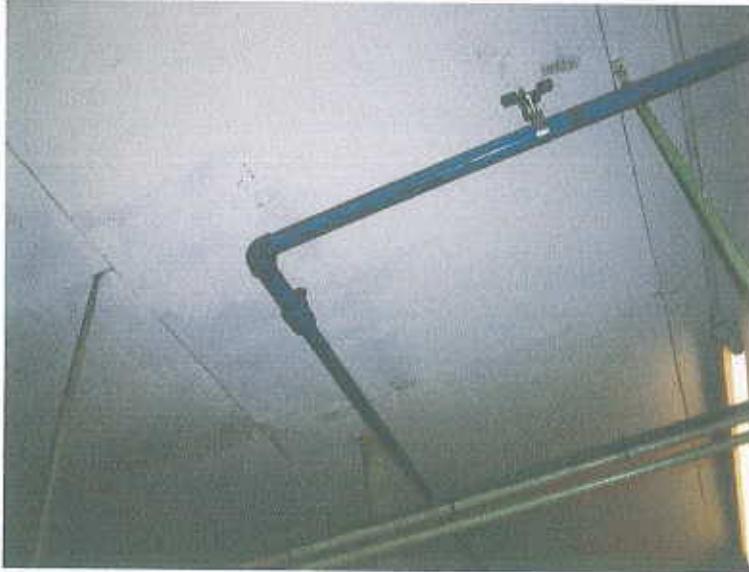
CLIENT	John Peel & Son Ltd	SITE	Baildon Mills, Northgate, Baildon, Shipley, West Yorkshire. BD17 6JY
SAMPLE REF.	390	SURVEY TYPE	T2
DATE TAKEN	30/12/2004	ASBESTOS TYPE	
AREA	ceiling	ANALYSIS	NADIS
FLOOR	Ground floor	CONDITION	NADIS
ROOM	Boiler room	FRIABILITY	NADIS
COMPONENT	Cerment sheets	POSITION	NADIS
SURVEYOR	Garrie Thomas & Dean Jepson	TREATMENT	NADIS
LAB	UKAS1689	MATERIAL RISK	0 (NADIS)
NEXT INSPECTION	June 2005	PRIORITY RISK	0 (NFA)
REMOVAL COST	TBQ		
ACTION	Encapsulate and Apply Warning Labels

Check condition every 6 months and record. Replace when necessary and apply a permit to work system.

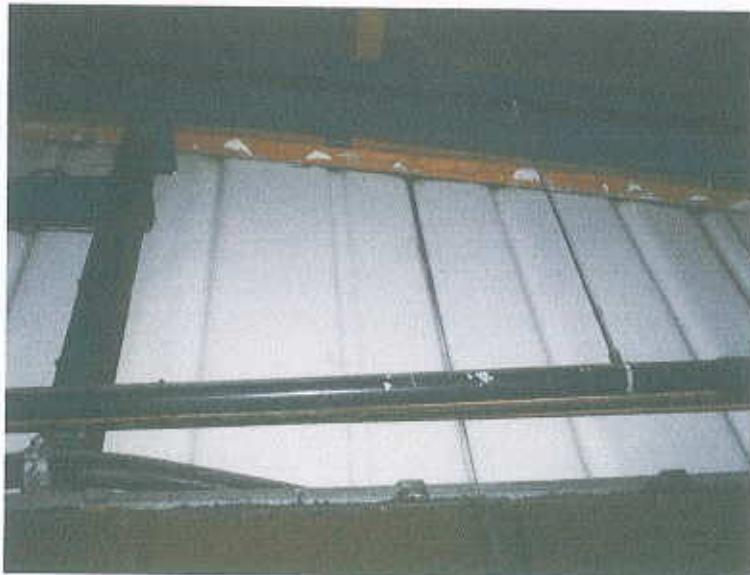
CLIENT	John Peel & Son Ltd	SITE	Baildon Mills, Northgate, Baildon, Shipley, West Yorkshire. BD17 6JY
SAMPLE REF.	392	SURVEY TYPE	T2
DATE TAKEN	30/12/2004	ASBESTOS TYPE	Chrysotile
AREA	16	ANALYSIS	Low
FLOOR	Ground floor	CONDITION	Fair
ROOM	Dye house	FRIABILITY	Low
COMPONENT	Cermnet profile	POSITION	External
SURVEYOR	Garrie Thomas & Dean Jepson	TREATMENT	Sealed
LAB	UKAS1689	MATERIAL RISK	3 (Very Low)
NEXT INSPECTION	June 2005	PRIORITY RISK	6 (Low)
REMOVAL COST	TBQ		
ACTION	Apply Warning Labels

Check condition every 6 months and record. Replace when necessary and apply a permit to work system.

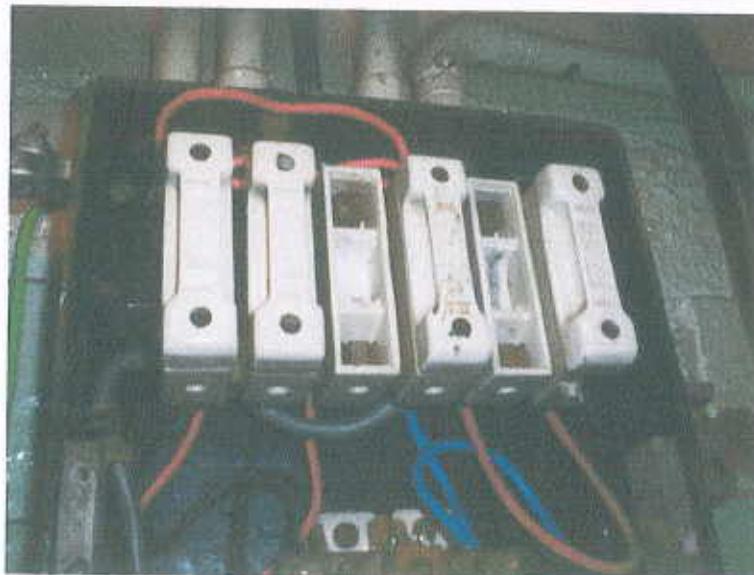
SAMPLE REF.	394	SURVEY TYPE	T2
DATE TAKEN	30/12/2004	ASBESTOS TYPE	Chrysotile
AREA	11	ANALYSIS	Significant
FLOOR	Ground floor	CONDITION	Fair
ROOM	Coridoor	FRIABILITY	High
COMPONENT	fuse cloth	POSITION	Internal
SURVEYOR	Garrie Thomas & Dean Jepson	TREATMENT	Unsealed
LAB	UKAS1689	MATERIAL RISK	14 (Medium)
INSPECTION	June 2005	PRIORITY RISK	4 (Very Low)
REMOVAL COST	TBQ		
ACTION	Apply Warning Labels to outer case.

Check condition every 6 months and record. Replace when necessary and apply a permit to work system.

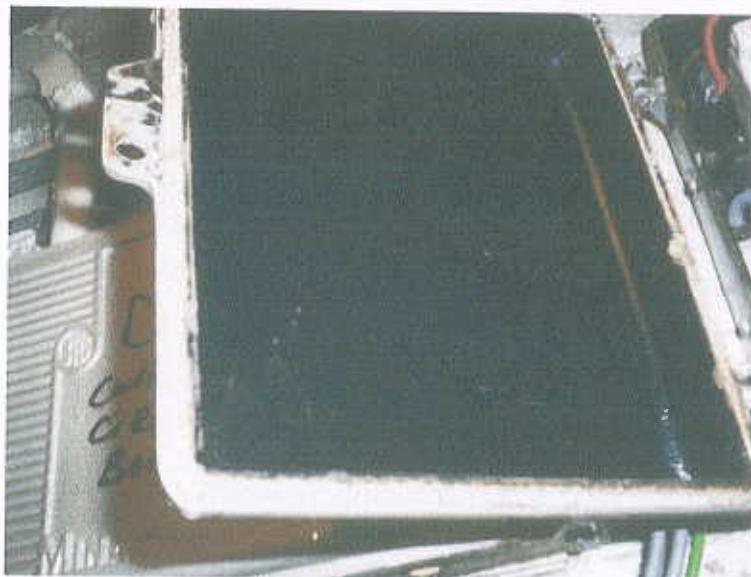
CLIENT	John Peel & Son Ltd	SITE	Baildon Mills, Northgate, Baildon, Shipley, West Yorkshire. BD17 6JY
SAMPLE REF.	395	SURVEY TYPE	T2
DATE TAKEN	30/12/2004	ASBESTOS TYPE	Chrysotile
AREA	13	ANALYSIS	Significant
FLOOR	Ground floor	CONDITION	Fair
ROOM	Electric cubboard	FRIABILITY	High
COMPONENT	Fuse cloth door seal	POSITION	Internal
SURVEYOR	Garrie Thomas & Dean Jepson	TREATMENT	Unsealed
LAB	UKAS1689	MATERIAL RISK	14 (Medium)
NEXT INSPECTION	June 2005	PRIORITY RISK	4 (Very Low)
REMOVAL COST	TBQ		
ACTION	Apply Warning Labels to outer case.

Check condition every 6 months and record. Replace when necessary and apply a permit to work system.

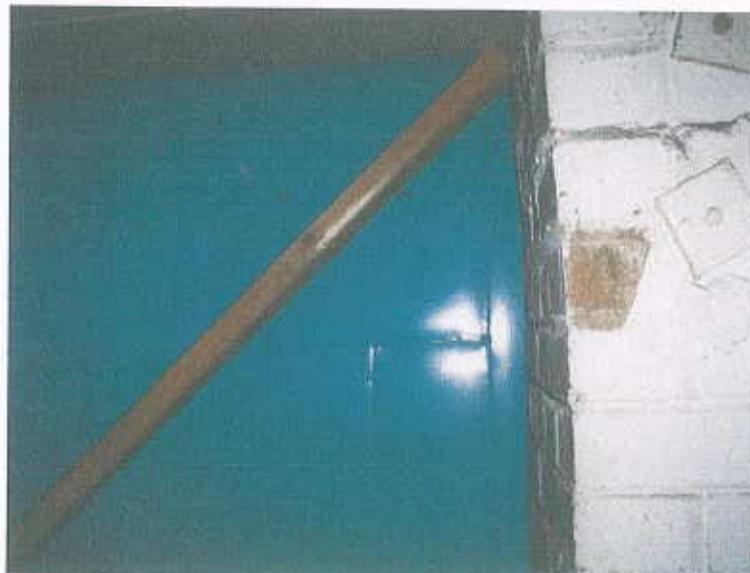
CLIENT	John Peel & Son Ltd	SITE	Baildon Mills, Northgate, Baildon, Shipley, West Yorkshire. BD17 6JY
SAMPLE REF.	396	SURVEY TYPE	T2
DATE TAKEN	30/12/2004	ASBESTOS TYPE	Chrysotile
AREA	12	ANALYSIS	Assumed Significant
FLOOR	Ground floor	CONDITION	Fair
ROOM	unit room	FRIABILITY	Low
COMPONENT	Fire door	POSITION	Internal
SURVEYOR	Garrie Thomas & Dean Jepson	TREATMENT	Unsealed
LAB	UKAS1689	MATERIAL RISK	10 (Low)
NEXT INSPECTION	June 2005	PRIORITY RISK	3 (Very Low)
REMOVAL COST	TBQ		
ACTION	Apply Warning Labels to outer case.

Could not gain access, Check at next service by competent person, apply a permit to work system until ACM's are confirmed/denied.

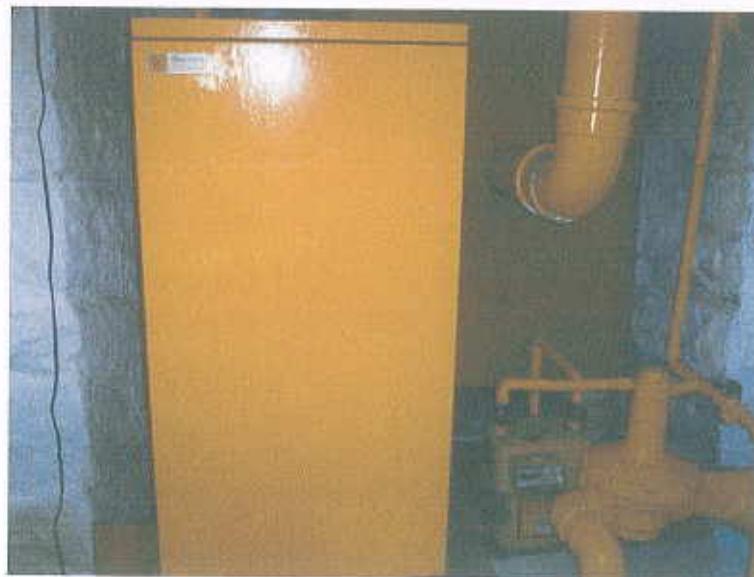
SAMPLE REF.	397	SURVEY TYPE	T2
DATE TAKEN	30/12/2004	ASBESTOS TYPE	Chrysotile
AREA	13	ANALYSIS	Assumed Significant
FLOOR	Ground floor	CONDITION	Fair
ROOM	S S Stores	FRIABILITY	Low
COMPONENT	Boiler	POSITION	Internal
SURVEYOR	Garrie Thomas & Dean Jepson	TREATMENT	Sealed
LAB	UKAS1689	MATERIAL RISK	6 (Very Low)
NEXT INSPECTION	June 2005	PRIORITY RISK	3 (Very Low)
REMOVAL COST	TBQ		
ACTION	Apply Warning Labels to outer case.

Could not gain access, Check at next service by competent person, apply a permit to work system until ACM's are confirmed/denied.

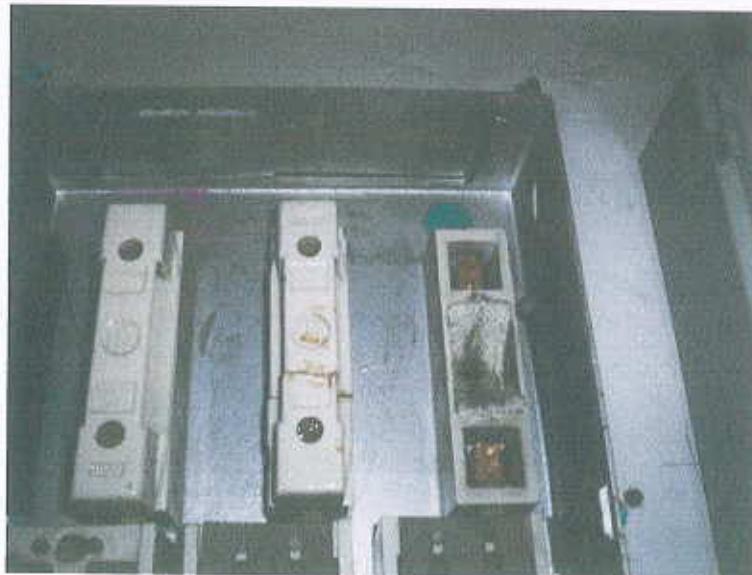
MATERIAL AND PRIORITY ASSESSMENT RECORD**CLIENT** John Peel & Son Ltd**SITE**Baildon Mills,
Northgate,
Baildon,
Shipley,
West Yorkshire.
BD17 6JY**SAMPLE REF.** 398**SURVEY TYPE** T2**DATE TAKEN** 30/12/2004**ASBESTOS TYPE** Chrysotile**AREA** 11**ANALYSIS** Significant**FLOOR** First floor**CONDITION** Fair**ROOM** Stores**FRIABILITY** High**COMPONENT** Fuse cloth & string x 3**POSITION** Internal**SURVEYOR** Garrie Thomas & Dean
Jepson**TREATMENT** Unsealed**LAB** UKAS1689**MATERIAL RISK** 14 (Medium)**NEXT INSPECTION** June 2005**PRIORITY RISK** 2 (Very Low)**REMOVAL COST** TBQ**ACTION** Apply Warning Labels to outer case.

Check condition every 6 months and record. Replace when necessary and apply a permit to work system.

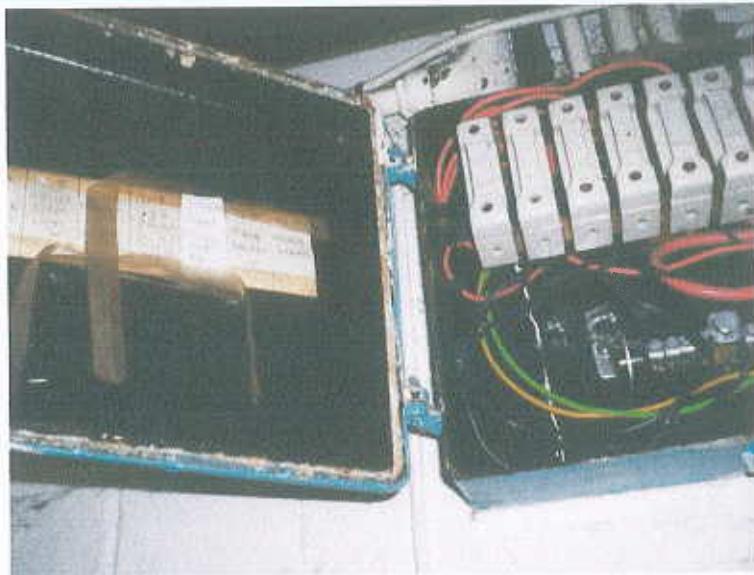
SAMPLE REF.	399	SURVEY TYPE	T2
DATE TAKEN	30/12/2004	ASBESTOS TYPE	Chrysotile
AREA	11 electrics	ANALYSIS	Significant
FLOOR	First floor	CONDITION	Fair
ROOM	Reception	FRIABILITY	High
COMPONENT	fuse cloth	POSITION	Internal
SURVEYOR	Garrie Thomas & Dean Jepson	TREATMENT	Unsealed
LAB	UKAS1689	MATERIAL RISK	14 (Medium)
NEXT INSPECTION	June 2005	PRIORITY RISK	4 (Very Low)
REMOVAL COST	TBQ		
ACTION	Apply Warning Labels to outer case.

Check condition every 6 months and record. Replace when necessary and apply a permit to work system.

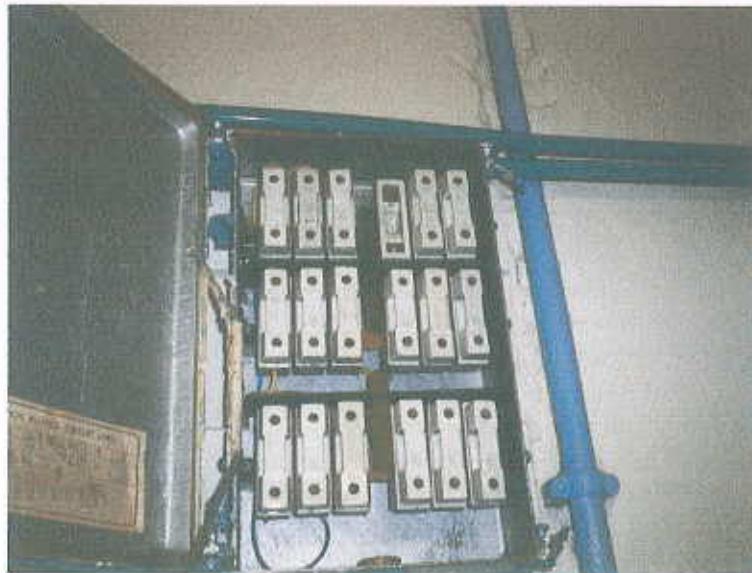
SAMPLE REF.	400	SURVEY TYPE	T2
DATE TAKEN	30/12/2004	ASBESTOS TYPE	Chrysotile
AREA	7	ANALYSIS	Significant
FLOOR	Ground floor	CONDITION	Fair
ROOM	Work shop	FRIABILITY	High
COMPONENT	Fuse cloth x 2	POSITION	Internal
SURVEYOR	Garrie Thomas & Dean Jepson	TREATMENT	Unsealed
LAB	UKAS1689	MATERIAL RISK	14 (Medium)
NEXT INSPECTION	June 2005	PRIORITY RISK	4 (Very Low)
REMOVAL COST	TBQ		
ACTION	Apply Warning Labels to outer case.

Check condition every 6 months and record. Replace when necessary and apply a permit to work system.

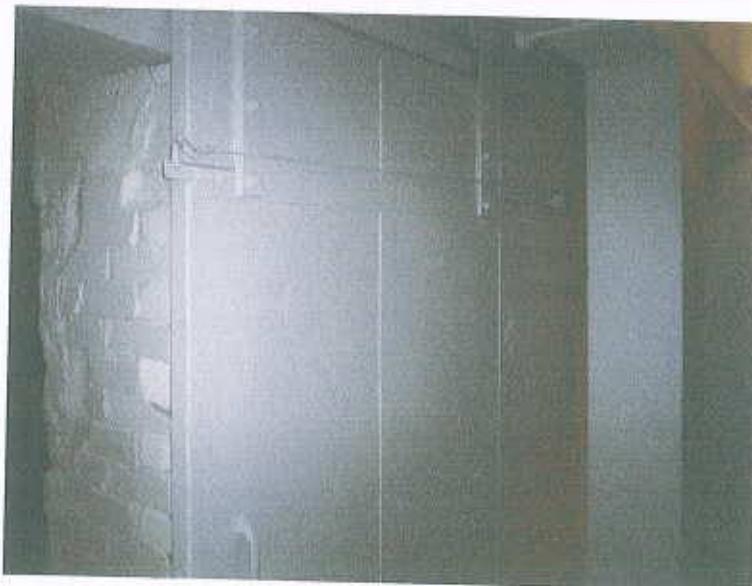
SAMPLE REF. 401 **SURVEY TYPE** T2
DATE TAKEN 30/12/2004 **ASBESTOS TYPE** Chrysotile
AREA 1 **ANALYSIS** Significant
FLOOR First floor **CONDITION** Fair
ROOM Corridor **FRIABILITY** Low
COMPONENT Fire doorx 2 **POSITION** Internal
SURVEYOR Garrie Thomas & Dean
Jepson **TREATMENT** Sealed
LAB UKAS1689 **MATERIAL RISK** 6 (Very Low)
NEXT INSPECTION June 2005 **PRIORITY RISK** 3 (Very Low)
REMOVAL COST TBQ
ACTION Apply Warning Labels to outer case.

Could not gain access, Check at next service by competent person, apply a permit to work system until ACM's are confirmed/denied.

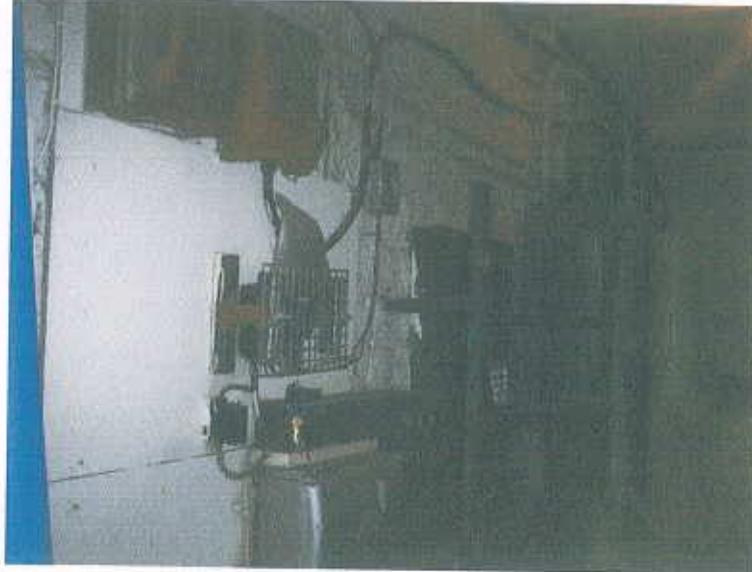
CONDITION Fair

ACTION Apply Warning Labels to outer case.

Could not gain access, Check at next service by competent person, apply a permit to work system until ACM's are confirmed/denied.

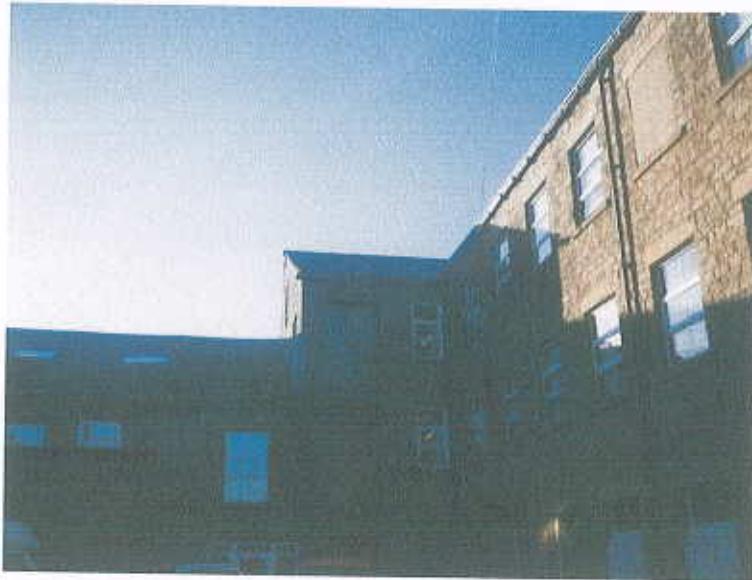
SAMPLE REF.	403	SURVEY TYPE	T2
DATE TAKEN	30/12/2004	ASBESTOS TYPE	Chrysotile
AREA	3/4/2/1	ANALYSIS	Low
FLOOR	External	CONDITION	Fair
ROOM	External	FRIABILITY	Low
COMPONENT	Profile/ridges & cement sheets	POSITION	External
SURVEYOR	Garrie Thomas & Dean Jepson	TREATMENT	Sealed
LAB	UKAS1689	MATERIAL RISK	3 (Very Low)
NEXT INSPECTION	June 2005	PRIORITY RISK	3 (Very Low)
REMOVAL COST	TBQ		
ACTION	Apply warning labels to underside

Check condition every 6 months and record. Re-encapsulate/ repair or replace when broken. Apply a permit to work system.
