Building inspection report

Baildon Mills
Northgate
Baildon
Shipley
West Yorkshire
BD17 6JY
United Kingdom

Report date: 14 March 2008

Client name: The Co-operative Group

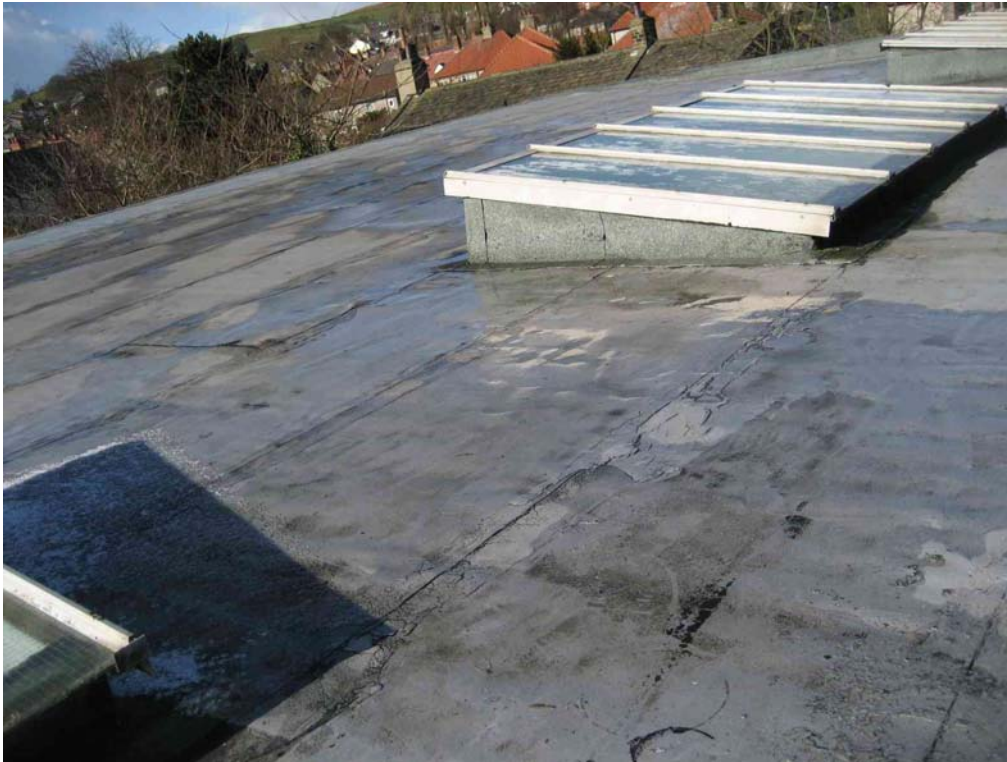
1. Roof to building 3

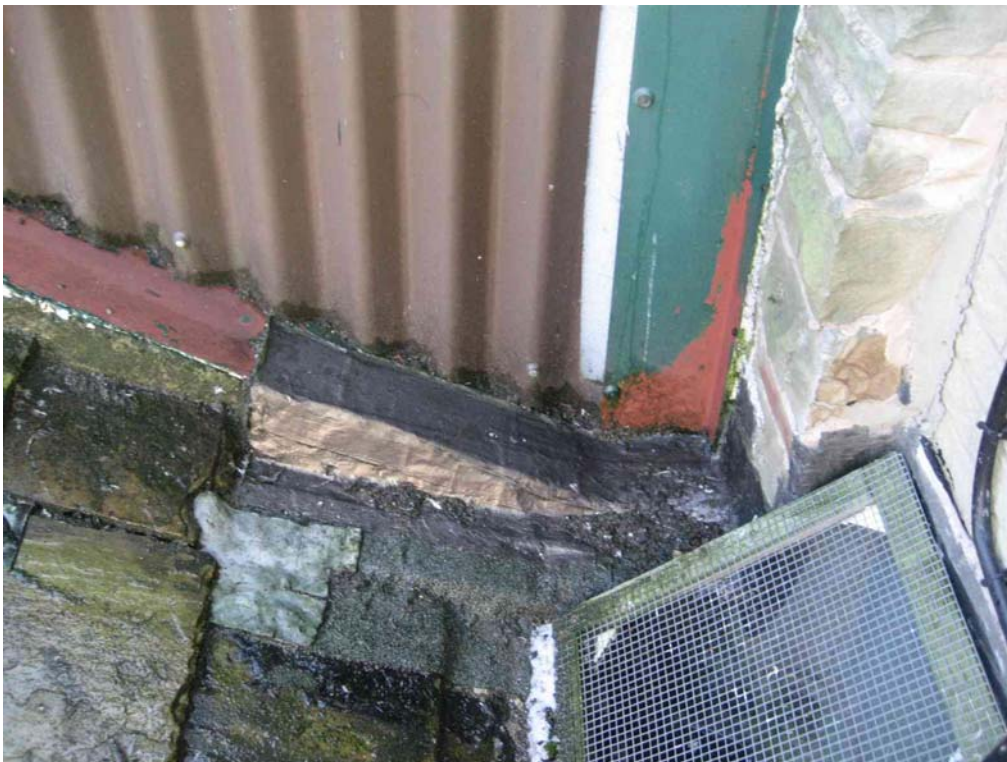
2. Patch repair to junction of building 4 and 16

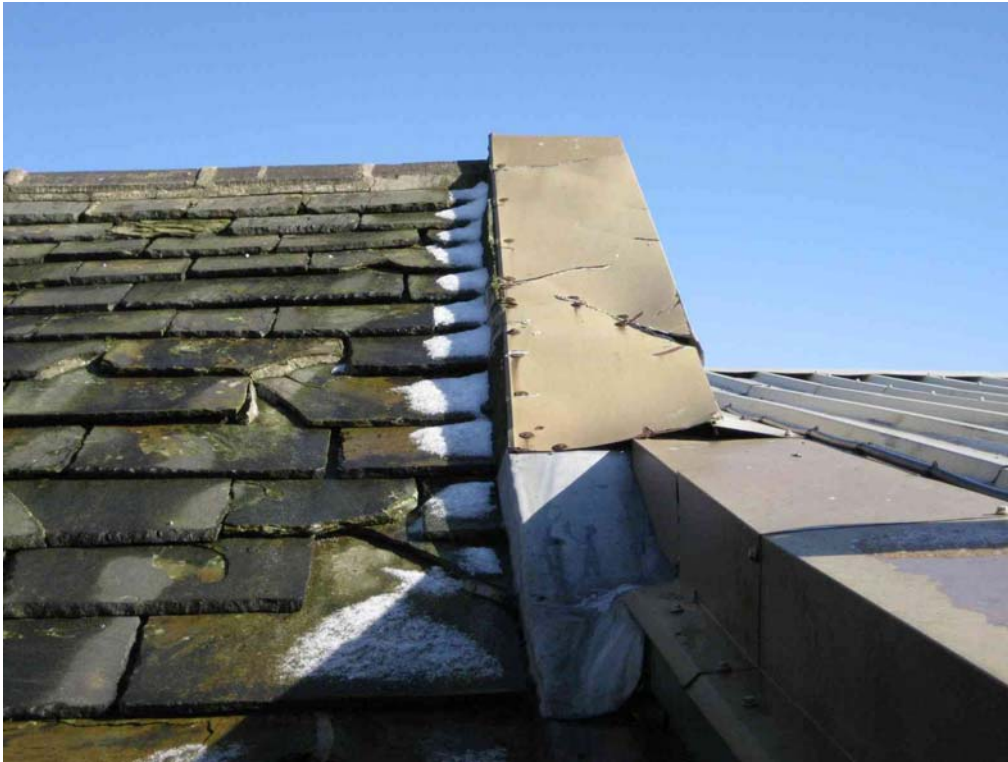
York stone roof coverings appear generally aged and are starting to delaminate. In addition areas of the stone paving are broken, and various flashband, temporary, repairs are present. Overall it is considered that stone roof coverings are approaching the end of their useful life expectancy. We consider that the York stone roof should be stripped and relaid and such work will need to allow for a portion of new stone. In addition rooflines generally appear to have sagged due to warping of the structural support with time, and some strengthening, or indeed renewal, of roof structures is likely to be required.

3. Example of decay to stone roof coverings

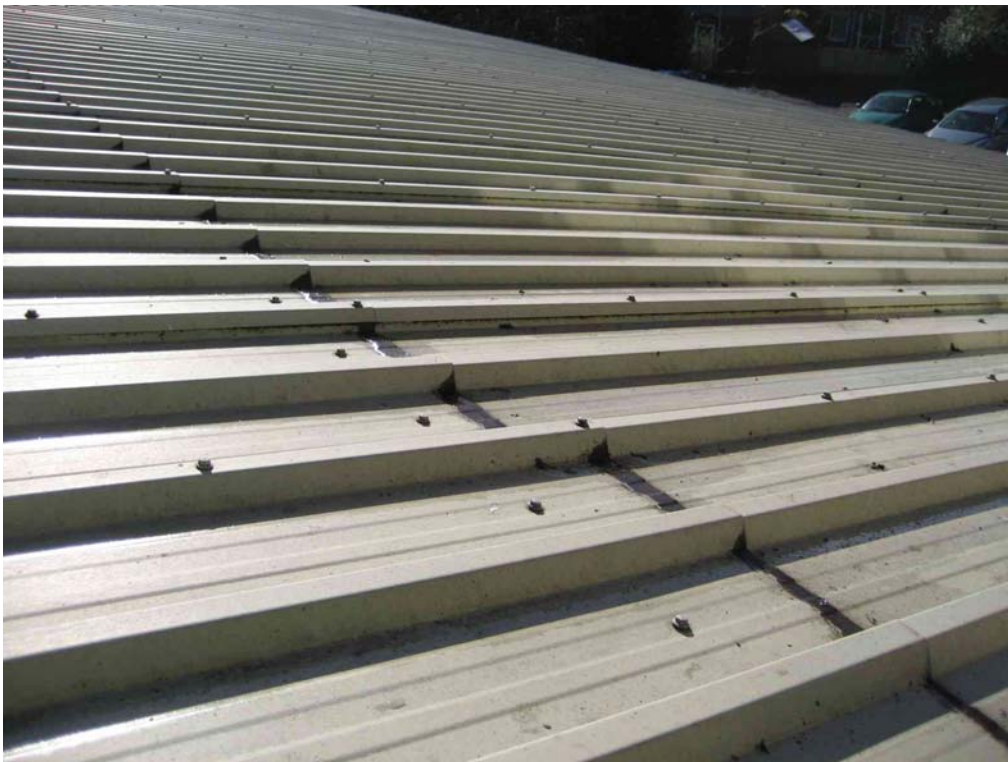
Coated profiled steel roof coverings are generally aged and extensive cut edge corrosion was noted as being present. If the covering is to be retained early treatment with an appropriate product such as Seamsil should be undertaken in order to reduce further corrosion. A number of the fixing caps to the roof areas appear to have become friable consideration will need to be given to their renewal in order to protect fixings. Again consideration should be given to a change in the roof covering for retail use.

4. Corrosion to steel roofing

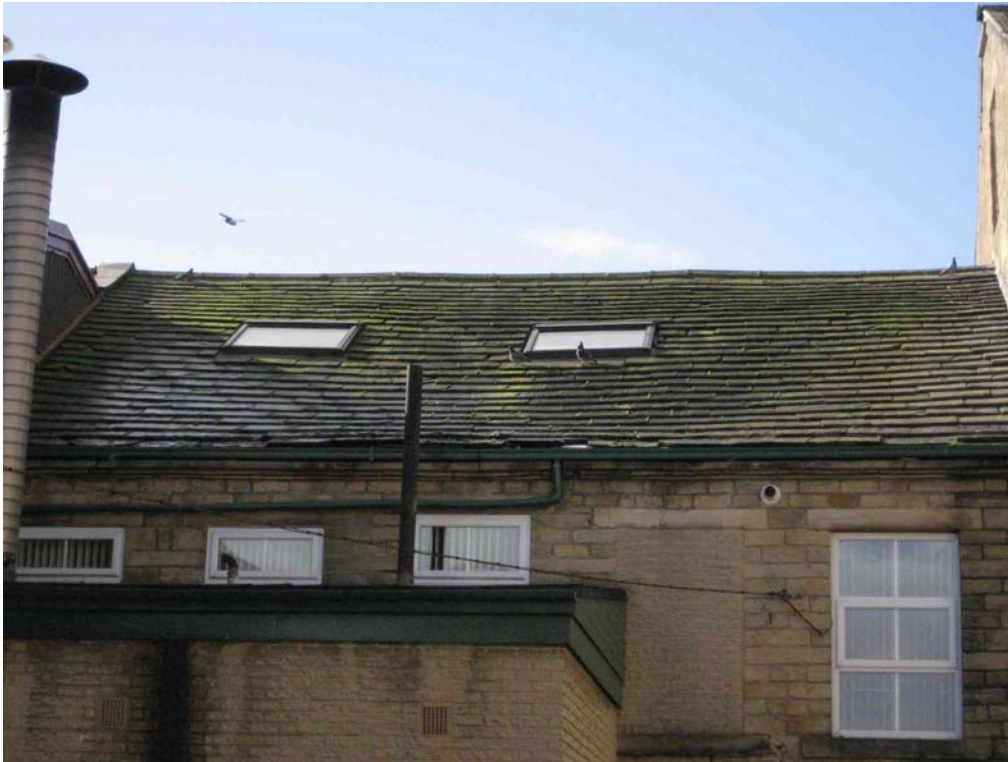
5. Overview of roof to building 4

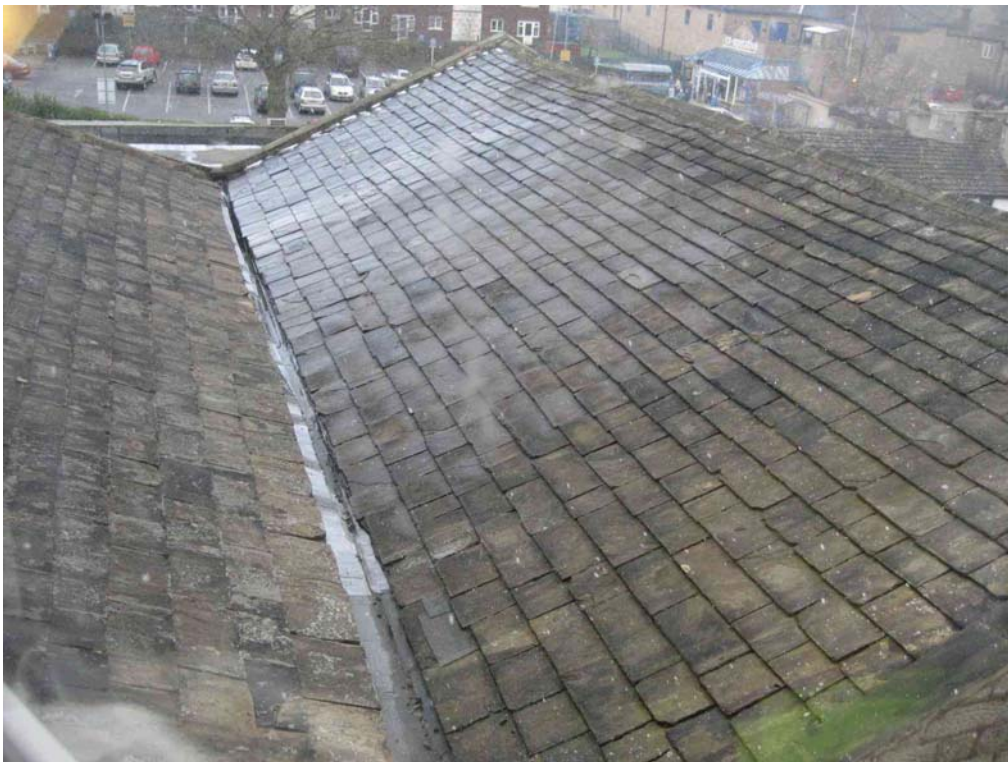
6. Roofs to buildings 12/13

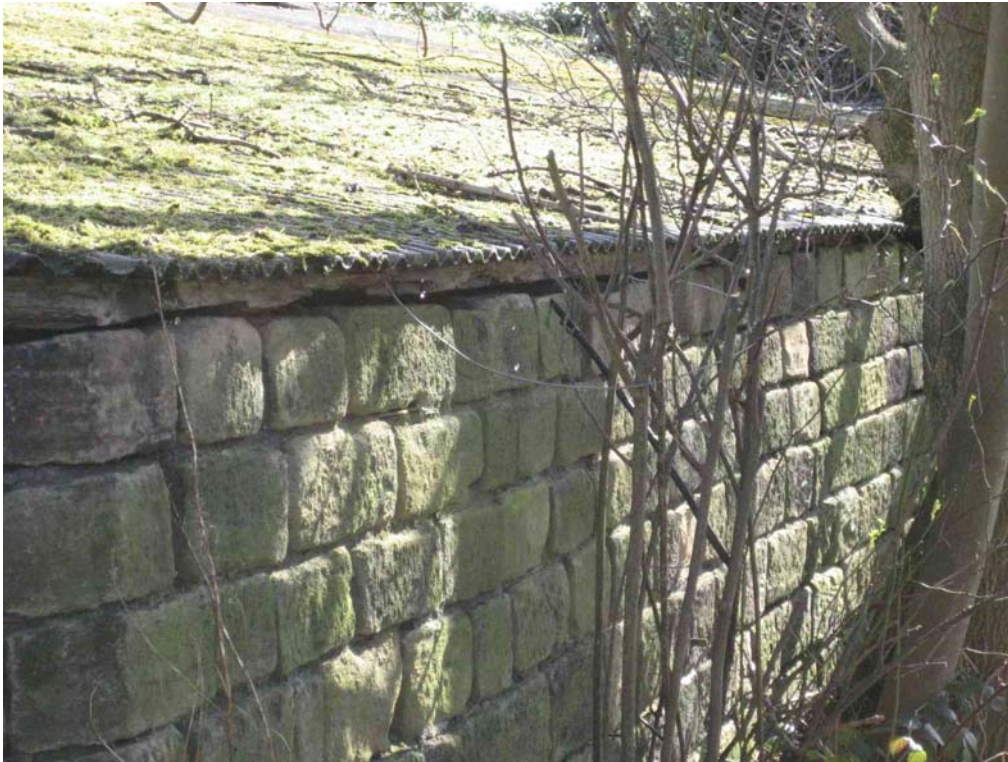
Garages to the northwest of the site appear to be generally in poor condition. In particular we noted extensive vegetation build up on the mono-pitched roof to the garage areas and this will be causing damage to the fibre cement roofing, which in turn is likely to have an asbestos content. Removal of the vegetation coupled with treatment of the sheeting should be considered. Timber bearers to the mono pitched roof of the garage appear in poor condition and in parts are likely to require renewal in the short term. We understand that the garages are individually let and details of these leases should be confirmed by your legal advisors.

7. Rear of garages

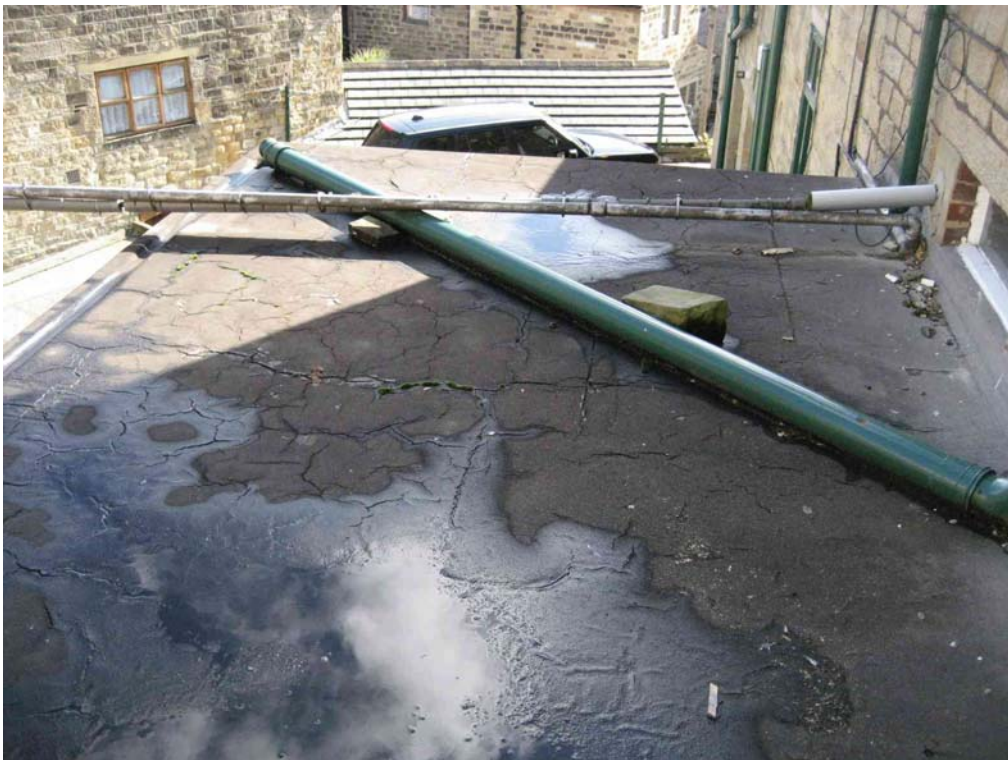
The asphalt finished roof to the sub-station is in extremely poor condition and requires renewal. Renewal is assumed to be the responsibility of the power company.

8. Roof to sub-station

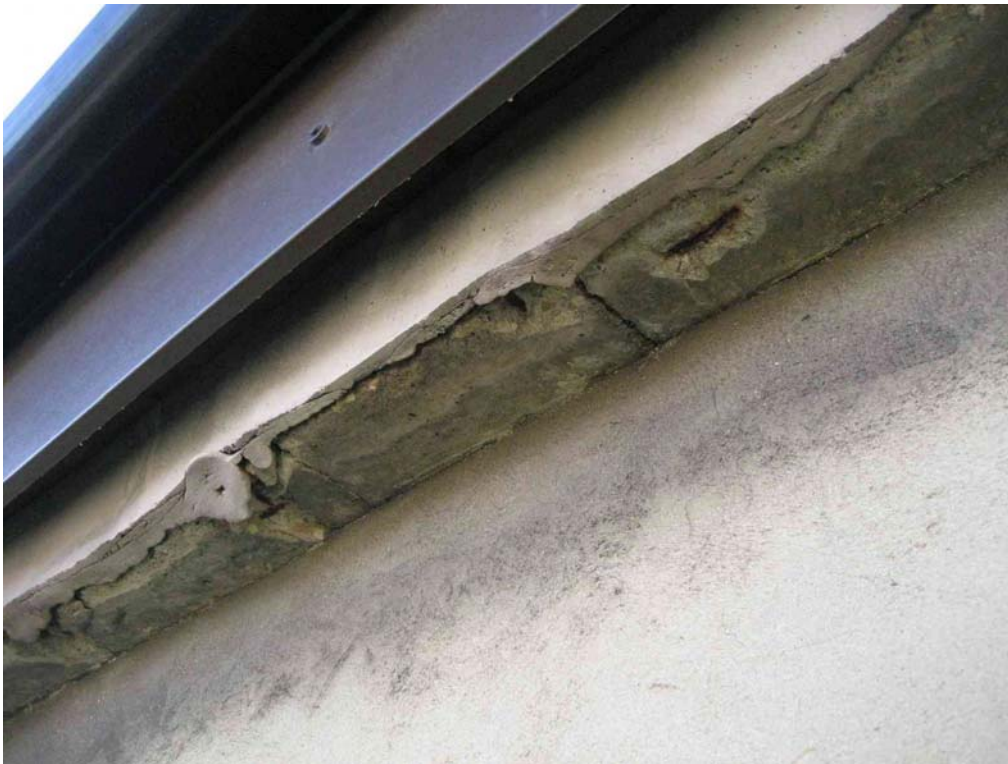
Pre-cast concrete is exposed to the front of buildings 7 to 9 and is spalling. The reinforcement to the concrete is rusting and we suspect that carbonation of the concrete has occurred. Testing is recommended followed by treatment to reduce future corrosion.

9. Spalling and corrosion to exposed pre-cast concrete units

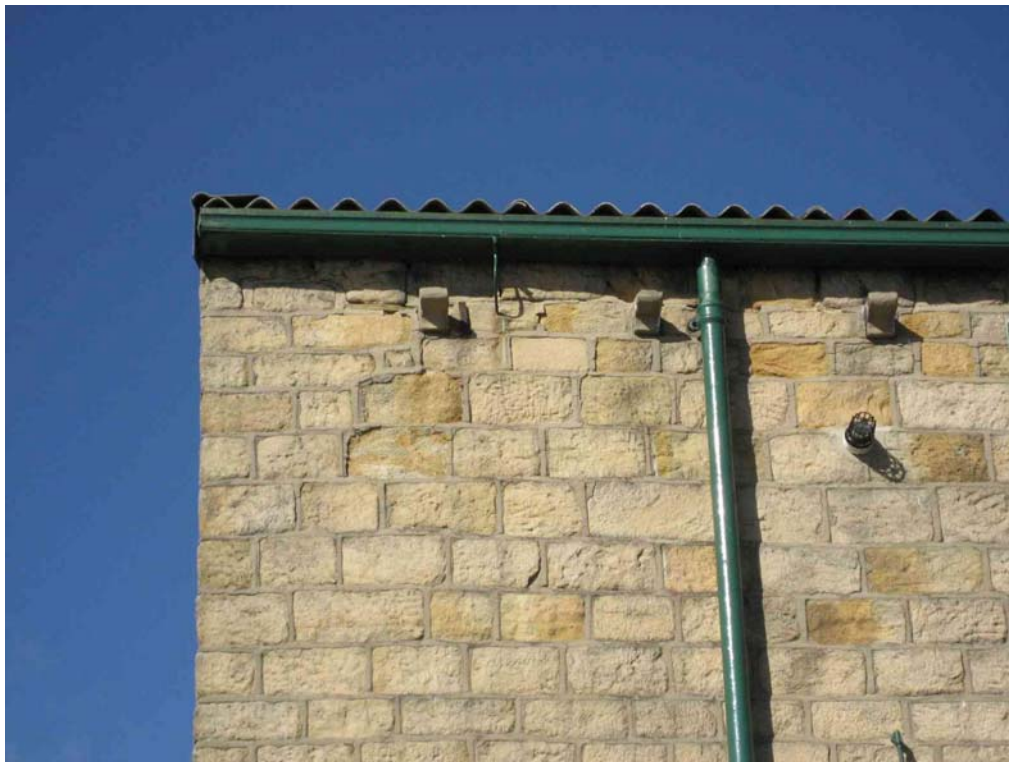
Localised damage and spalling of stone was noted, appearing due to general weathering or localised damage. Patch repairs only are required.

10. Example of erosion of stone

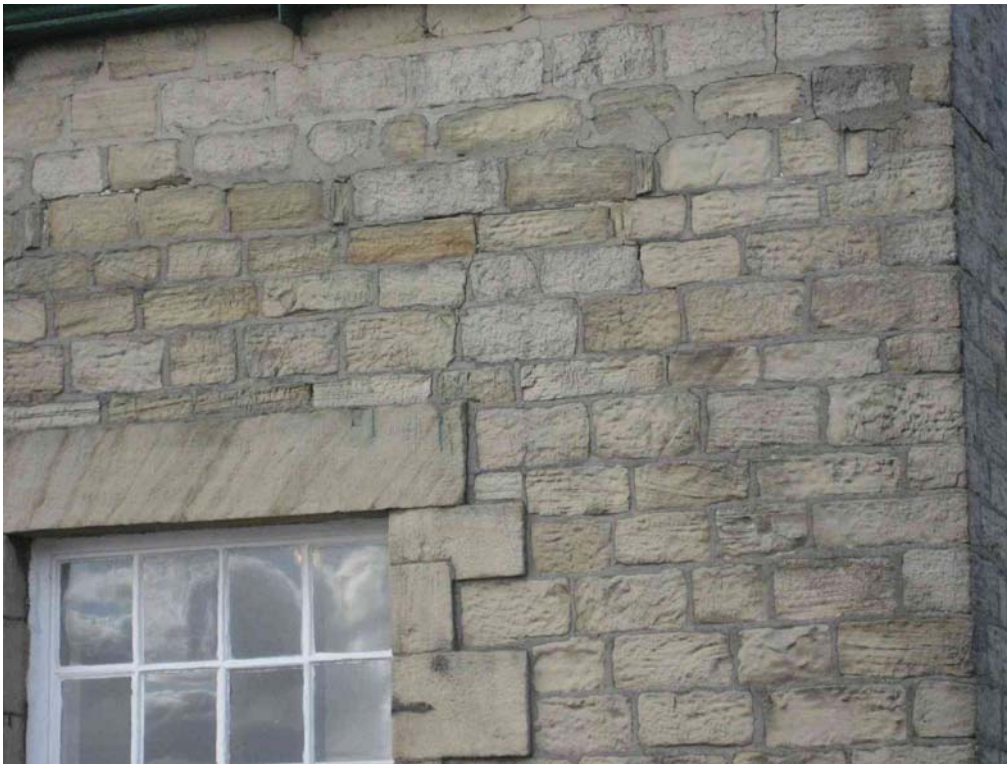
11. Example of cracking

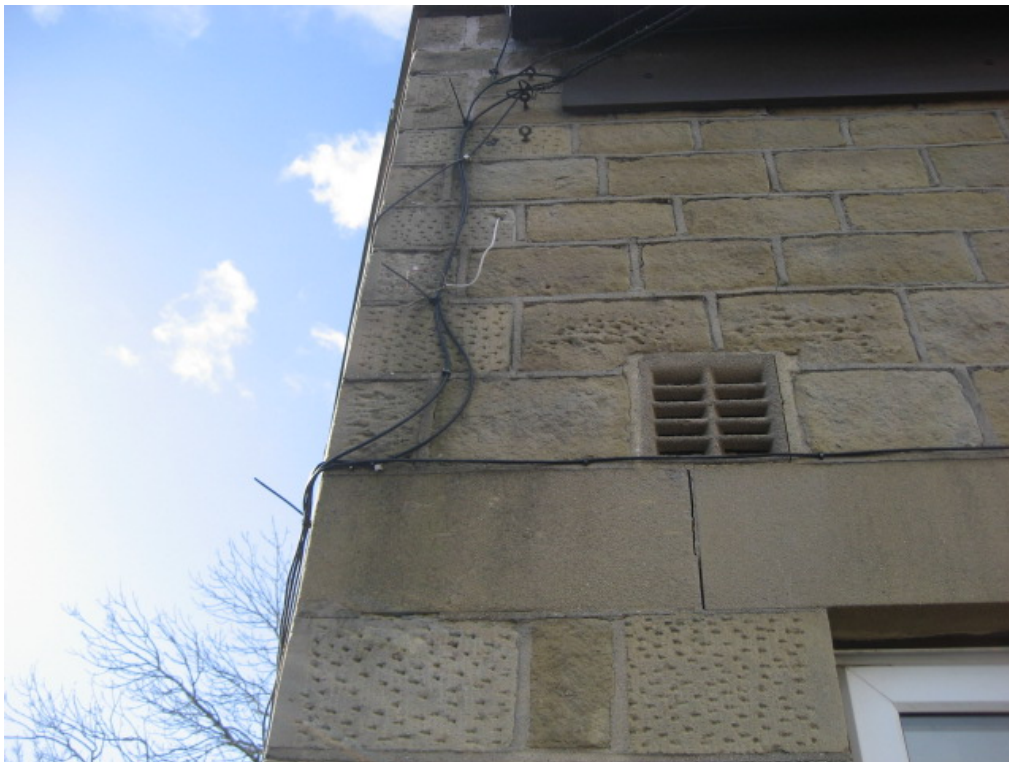
12. Example of cracking to elevation

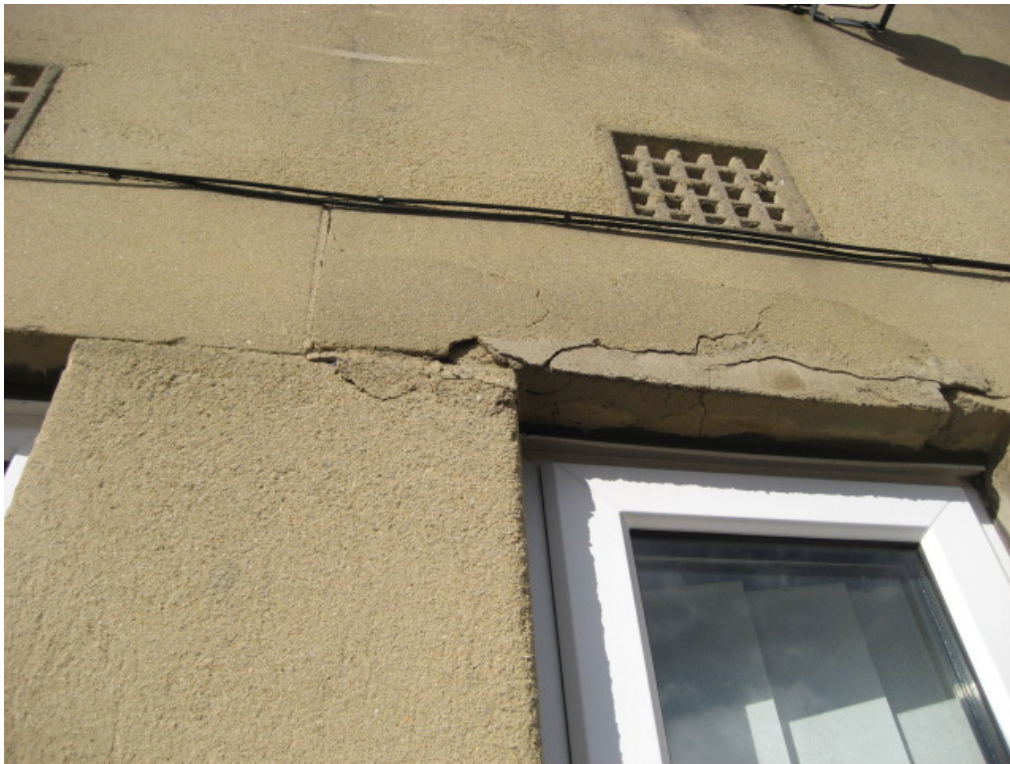
13. Example of spalling

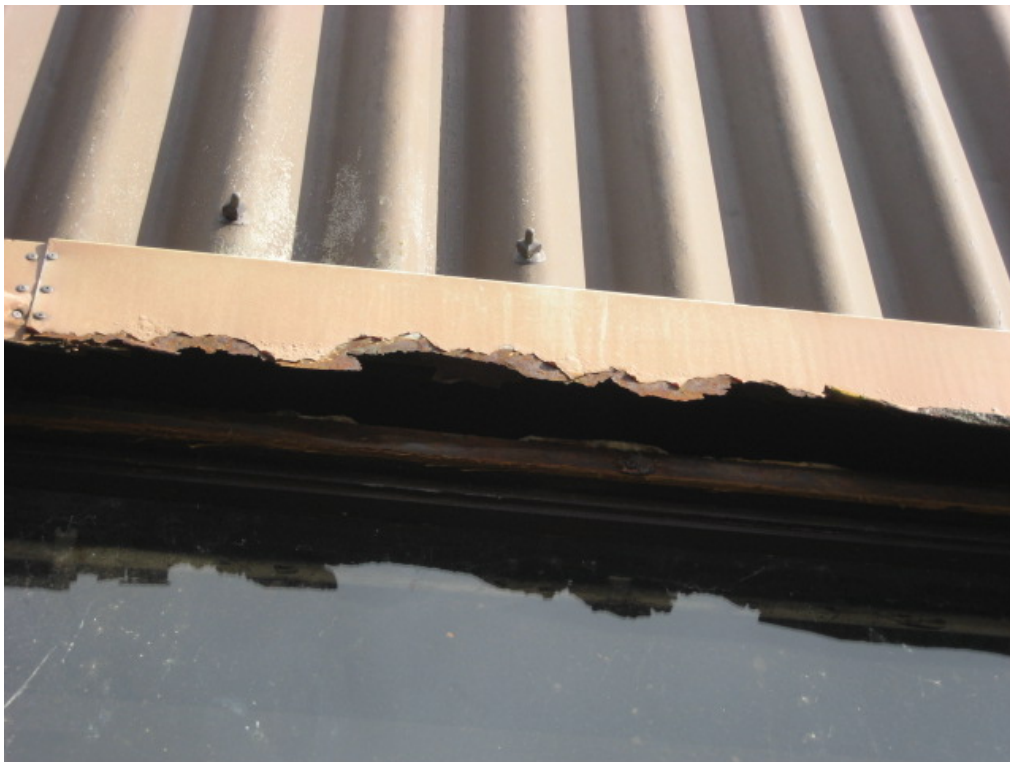
14. Corrosion to cladding

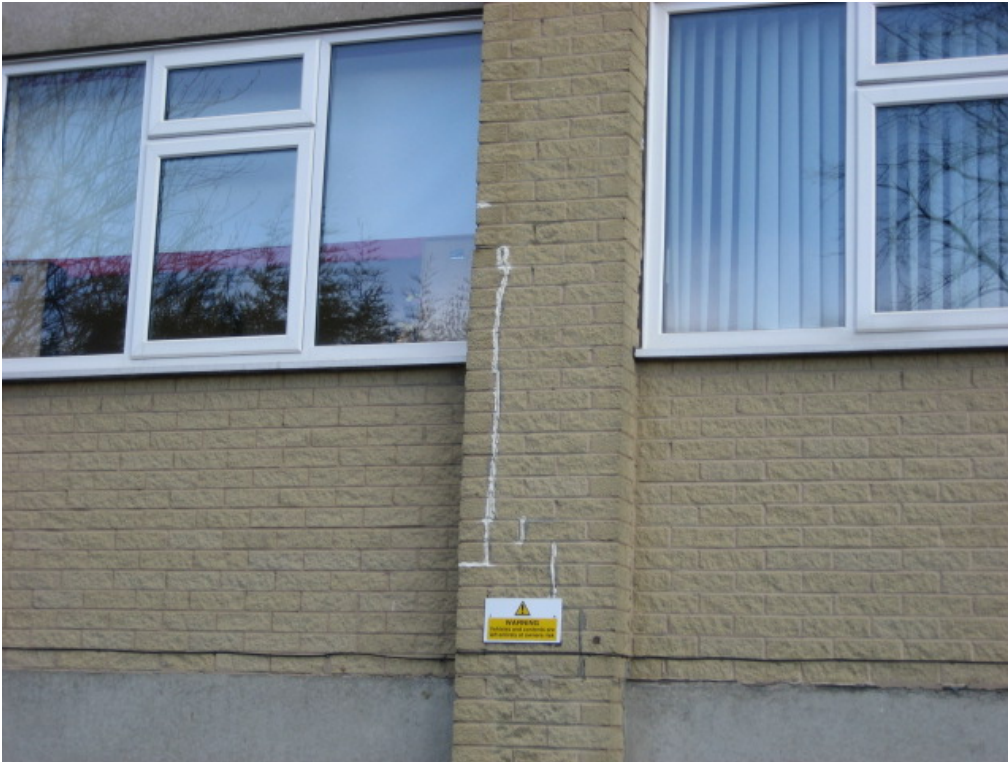
To the rear of building 3 cracking is present to walling, and historic repairs have been undertaken. The building in this location is of framed construction and cracking appears due to differential movement between the concealed frame and the brick cladding. Exposure of the frame together with re-detailing of the junction between brickwork and the frame should be undertaken. To the rear of the production unit cladding has become heavily corroded and cladding coating overall has degraded. Consideration should be given to renewal of the cladding to the rear elevation accordingly.

15. Historic crack to building 3

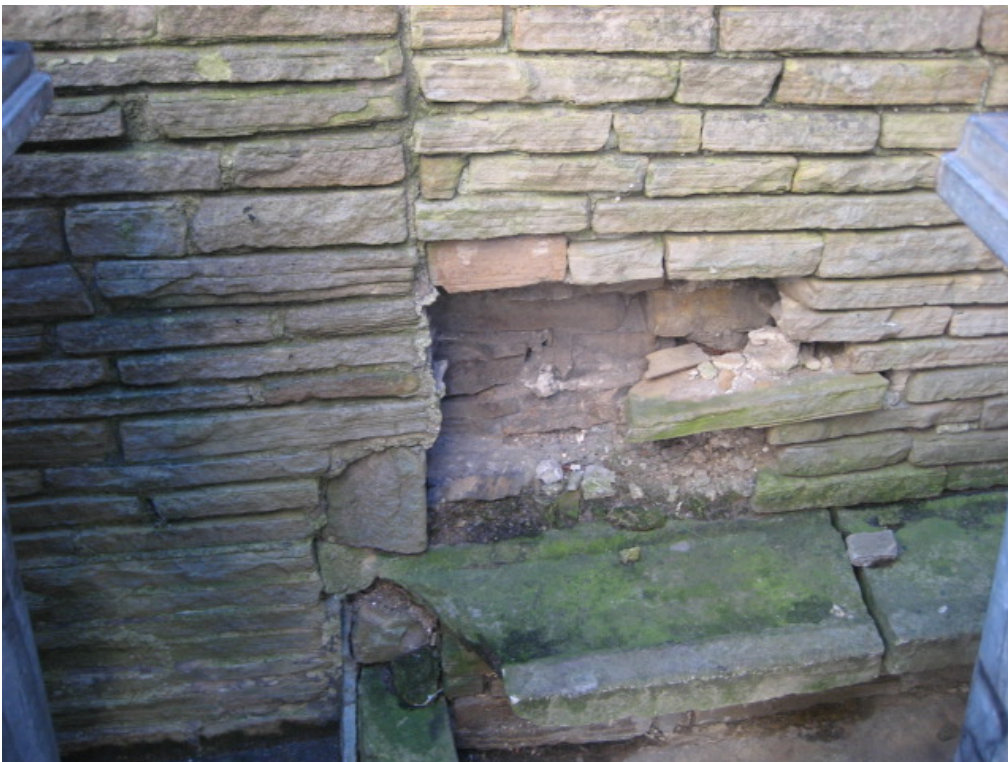
16. Missing stone

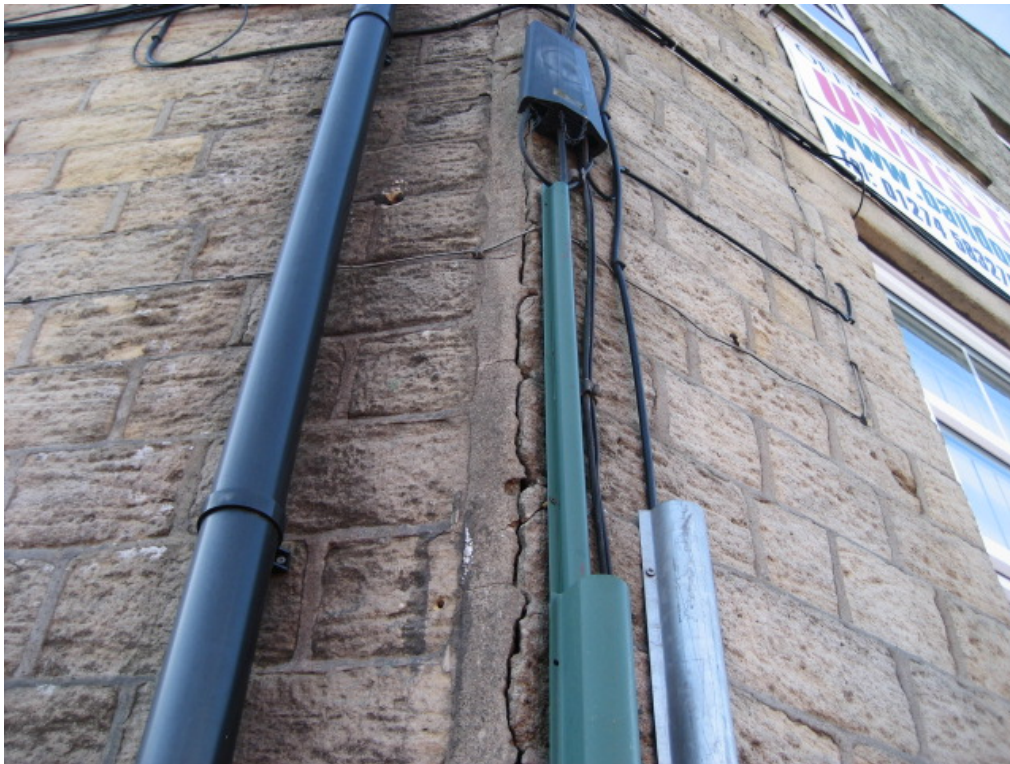
17. Example of cracking

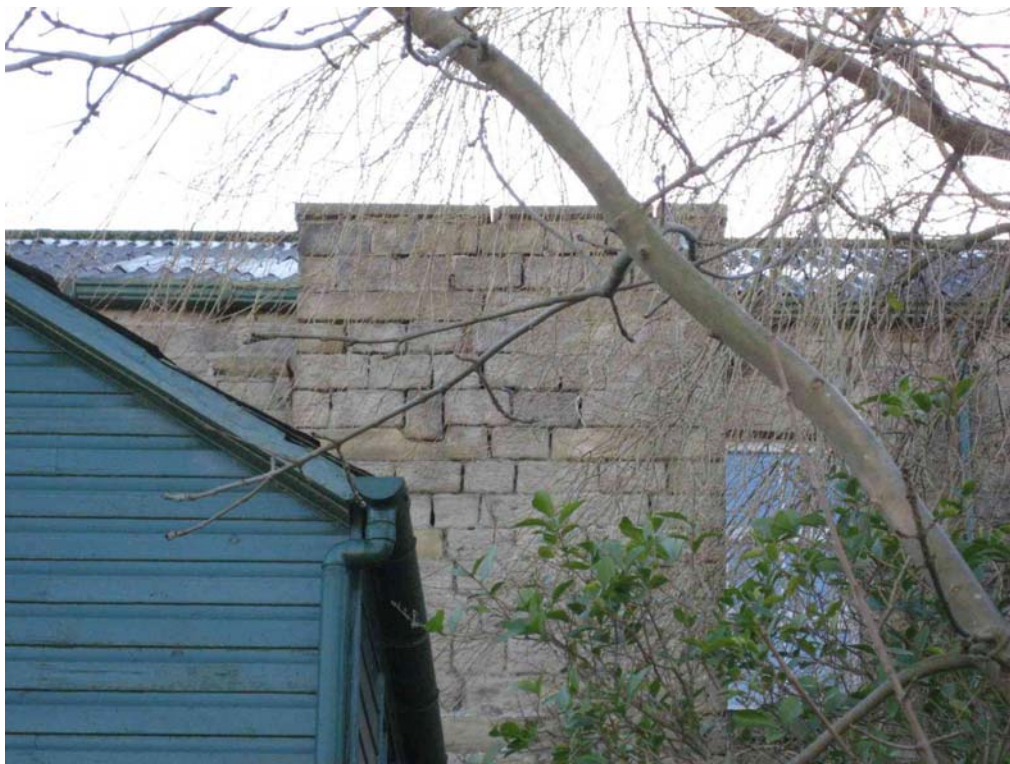
18. Open joints to corner of building 14

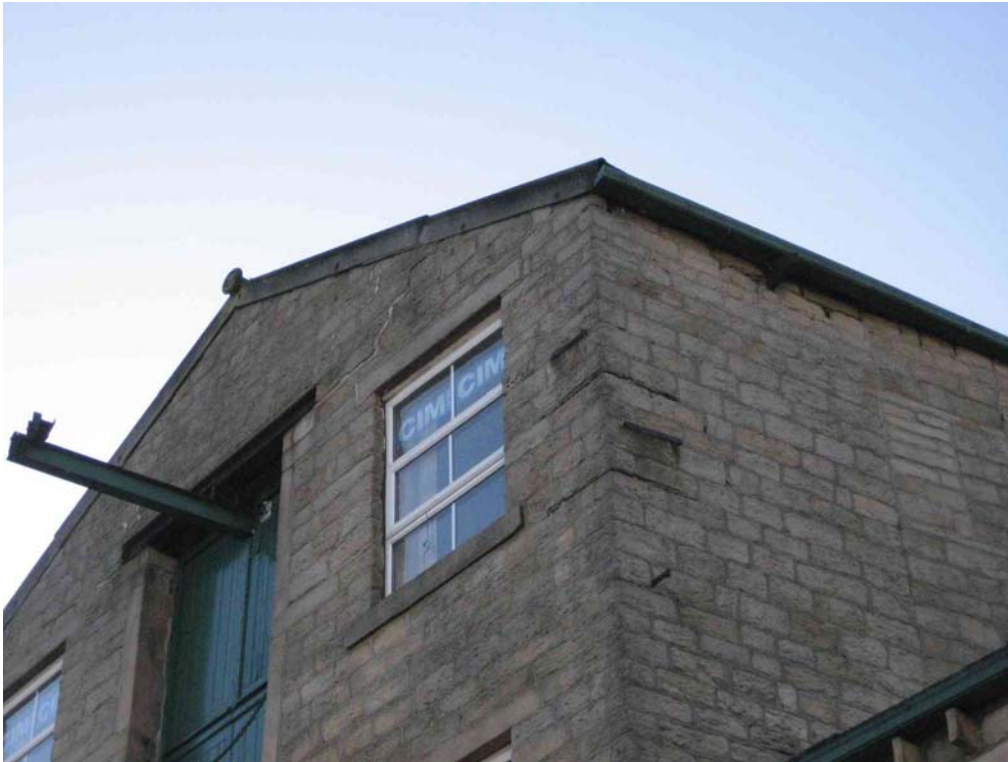
19. Cracking to building 12

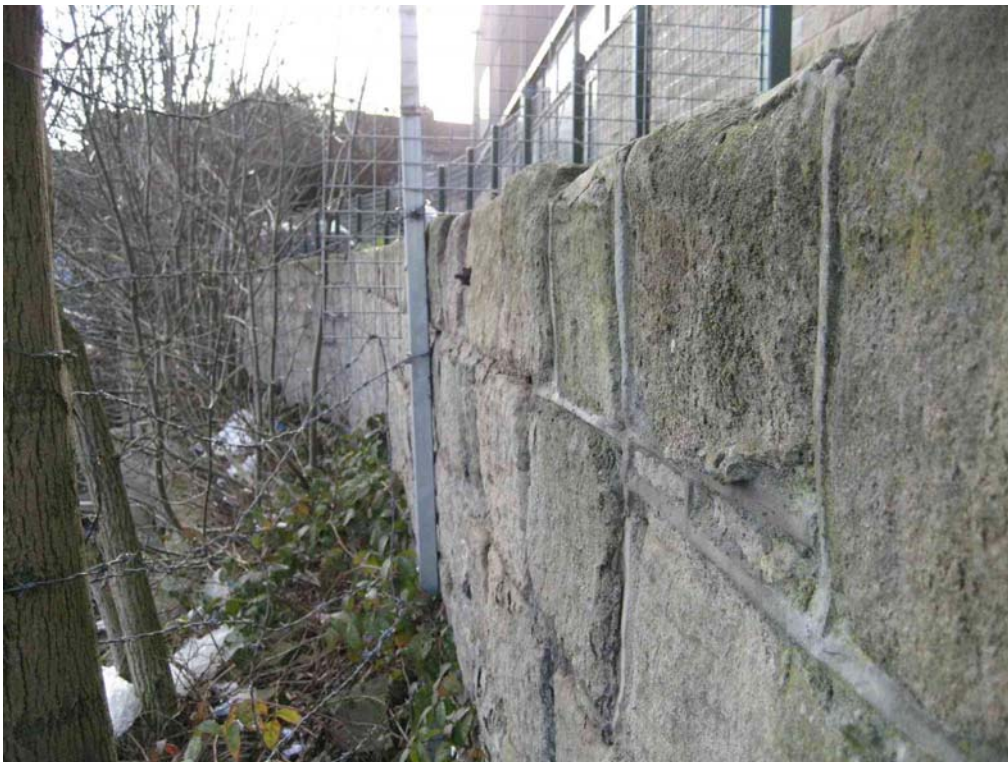
20. Leaning retaining wall to production area

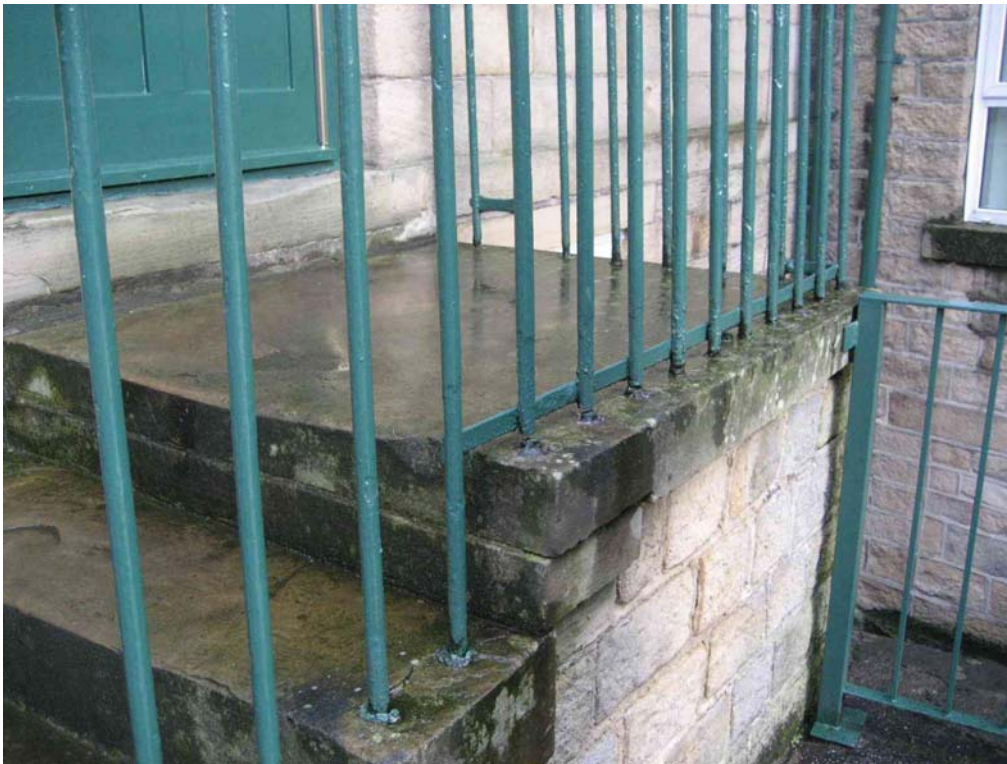
The handrails to various stairs are however generally considered inadequate and consideration should be given to their replacement in line with current building regulations.

21. Balustrading to estate office stair

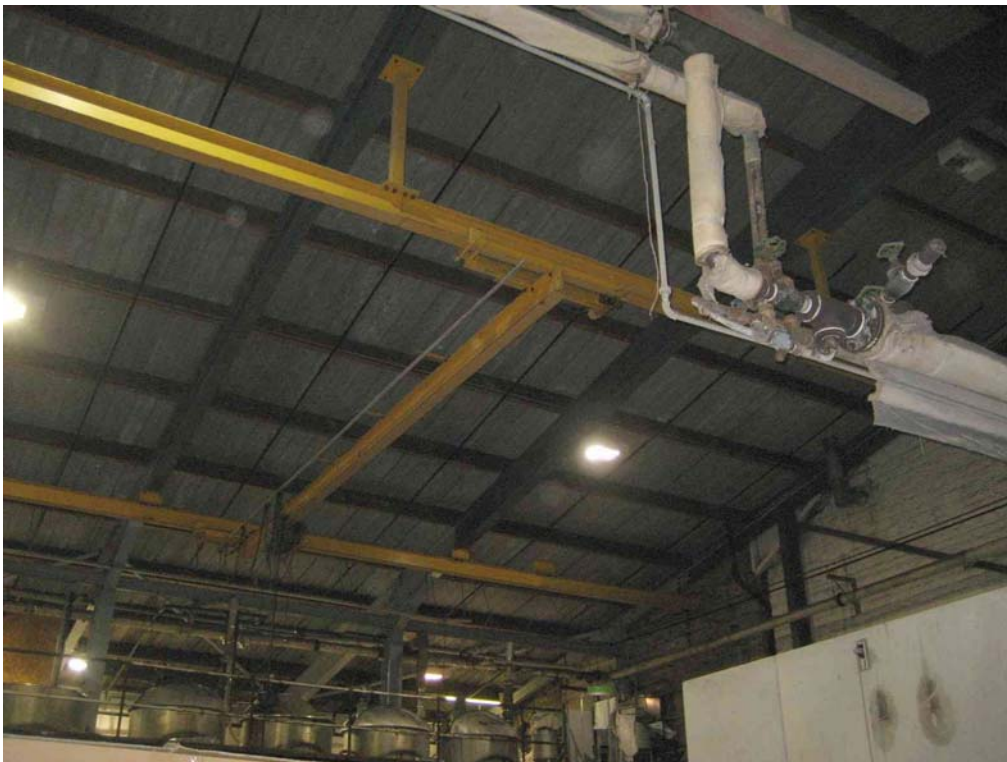
22. Soffit to production area roof

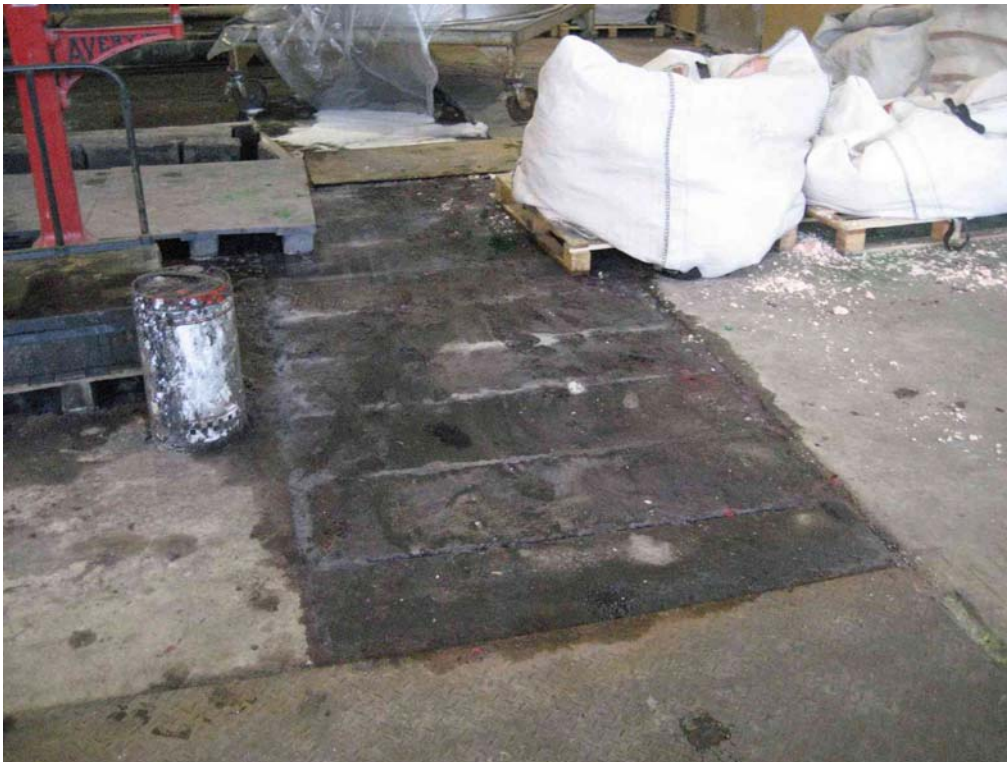
23. Covers to pit in production area

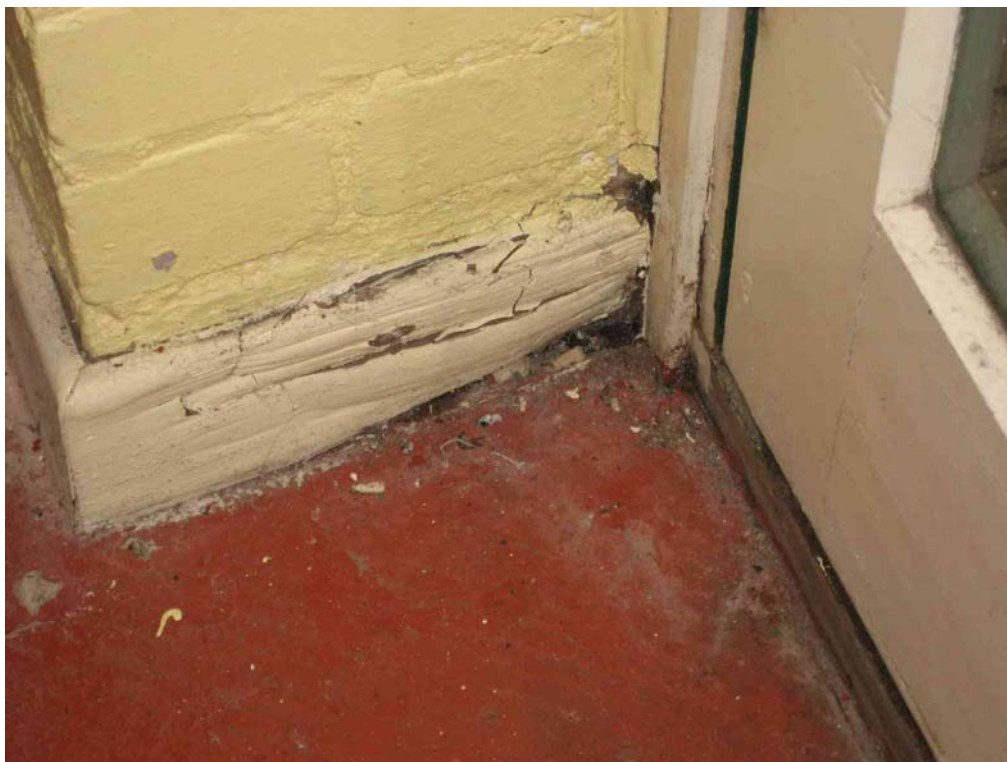
Within unit 8 we noted rot to the skirting adjoining the entrance door, though could not ascertain whether the attack was due to dry or wet rot. The affected timber should be removed and the area treated to prevent moisture penetration. The areas of timber concerned is relatively small and even if proved to be dry rot we do not consider there to be significant cause for concern.

24. Rot to building 8

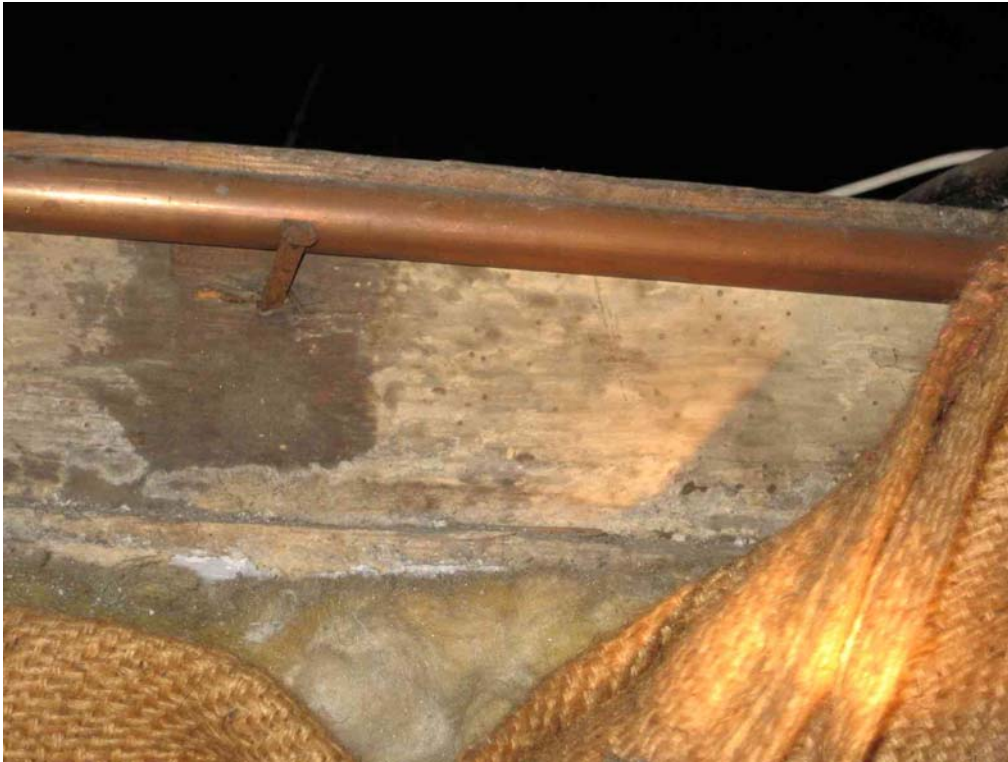
Within the office building 13 we noted damage to the roof structure due to wood boring beetle. Whilst to the area inspected the beetle attack appeared to be of long-standing we do consider that further inspection of the timber should be undertaken once appropriate access can be obtained. It is likely that a number of timbers will require renewal. Given the presence of beetle attack to part of the site we feel it is likely that further timber decay will be found in concealed areas and that remedial timber repairs will prove necessary. Overall however timber elements appear limited in nature and the presence of wood boring beetle attack in itself is unlikely to add significantly to development costs as remedial structural works are required for other reasons.

25. Evidence of wood boring beetle attack to building 13

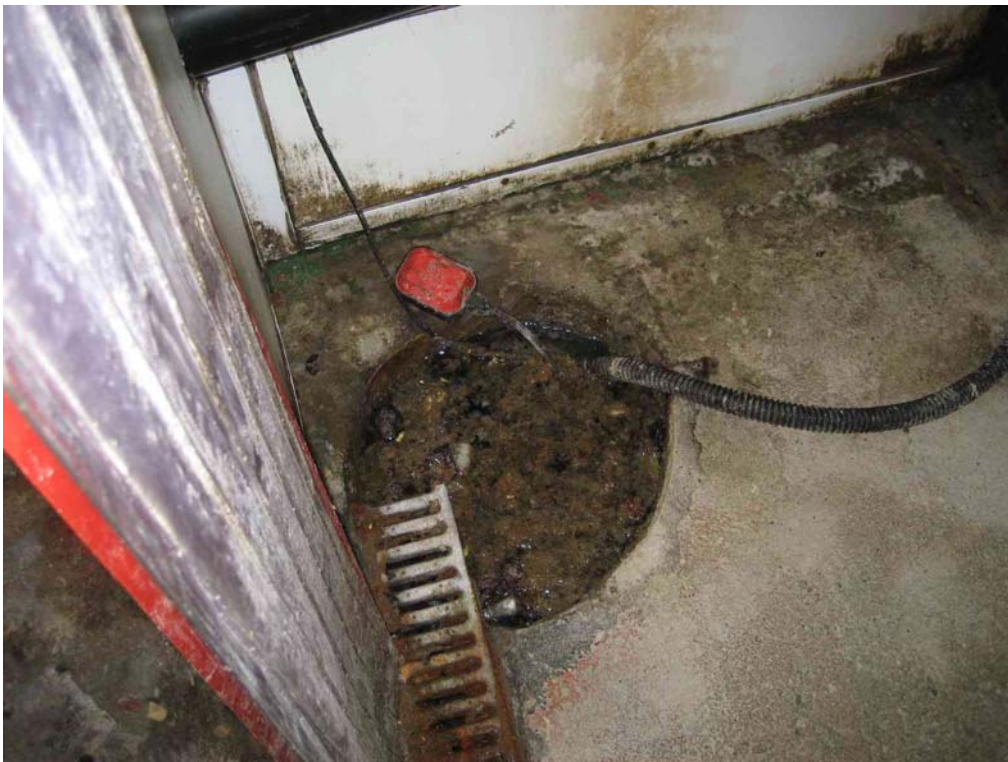
Within the basement of building 11 we noted the presence of a sump pump to the cold store areas. The drain fed by the pump appears to be partially blocked and we consider requires clearing. The area generally will require cleaning of contamination arising from the blocked drain.

26. Sump to basement building 13

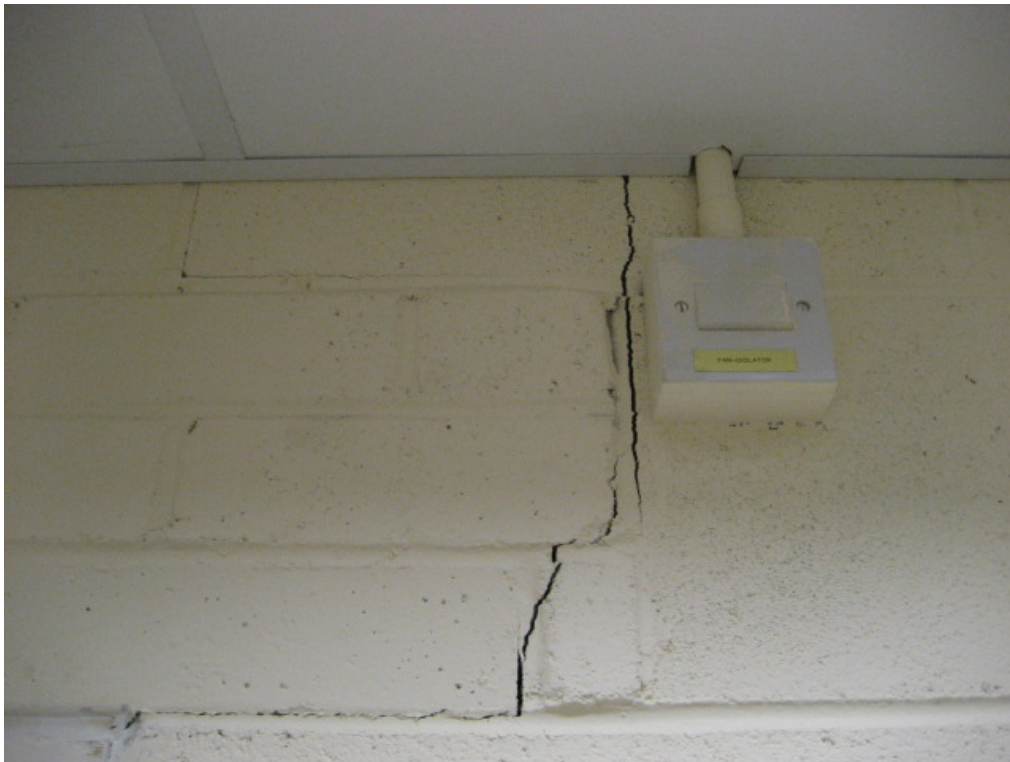
27. Example of internal cracking

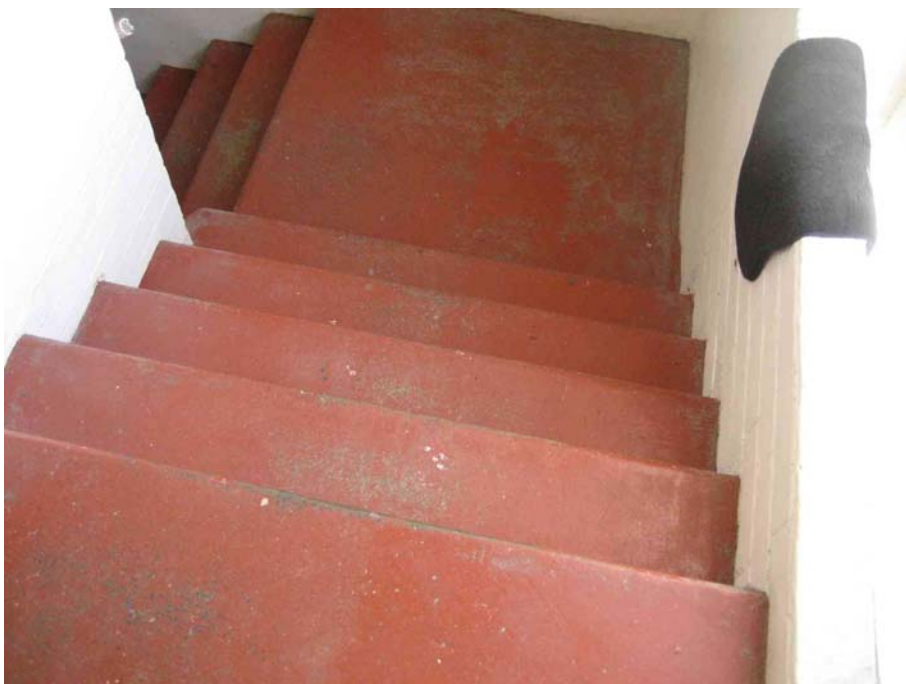
14. Lack of highlighting to steps
