Building inspection report

Baildon Mills
Northgate
Baildon
Shipley
West Yorkshire
BD17 6JY
United Kingdom

Report date: 14 March 2008

Client name: The Co-operative Group

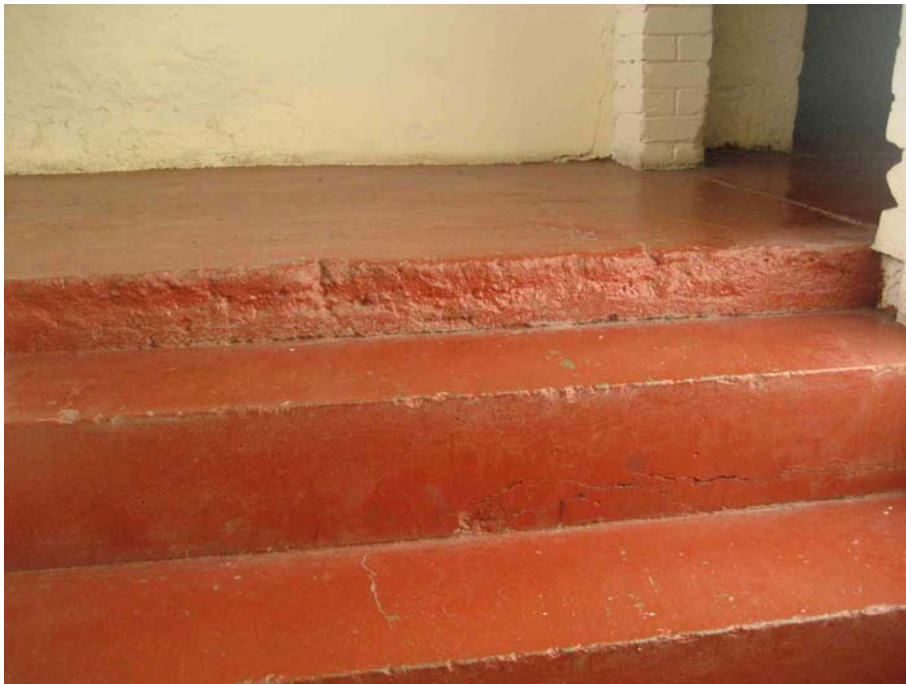
To building 1 we noted the step at the head of one stair was considerably different in height than the stair overall flight. Re-levelling of the stair is recommended.

15. Shallow step to stairs to building 1
