Project Name: HollyCroft Construction LTD -Baildon Mills -PJ00332160 -
26-04-19

Project Date: 26/04/2019

Project Standard: MSCC5 Sewers & Drainage GB (SRM5 Scoring)

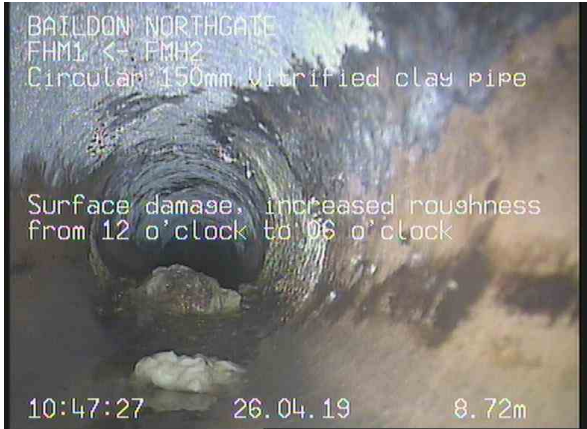
FHM1X_da6e11aa-340a-490b-9029-361575704d35_20190426_114731_845.jpg, 00:02:17, 8.72m
 Surface damage, increased roughness from 12 o'clock to 06 o'clock

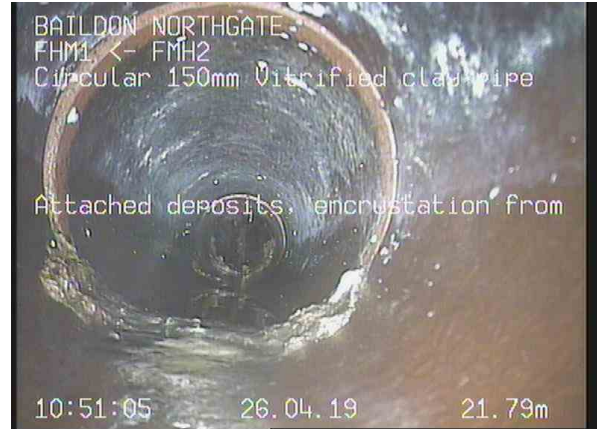
FHM1X_e696a407-eba3-42f9-9374-6ce6d4706b81_20190426_115110_459.jpg, 00:04:57, 21.79m
 Attached deposits, encrustation from 05 o'clock to 08 o'clock, 5% cross-sectional area loss

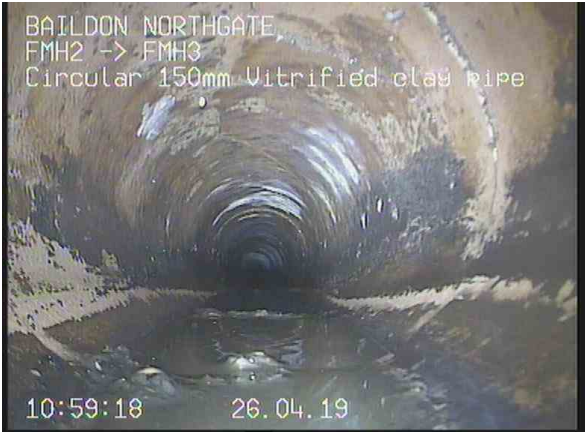
FMH2X_e441ac73-54a0-4fd0-aa70-d03f2ddc3234_20190426_115923_522.jpg, 00:01:51, 4.23m
 Fractures, multiple from 12 o'clock to 12 o'clock

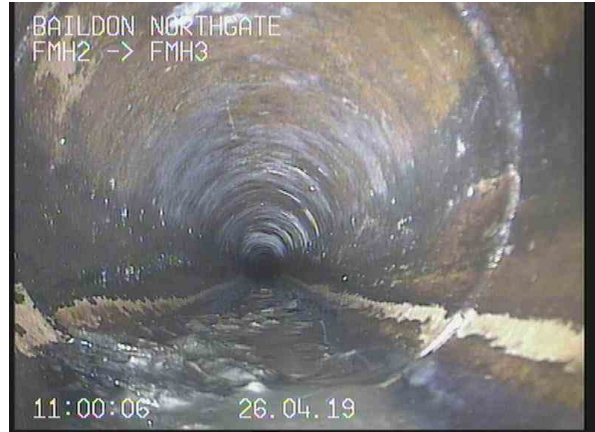
FMH2X_fed6c56c-b69e-404e-a153-260b08a9bd37_20190426_120011_601.jpg, 00:02:19, 5.02m
 Crack, longitudinal at 12 o'clock

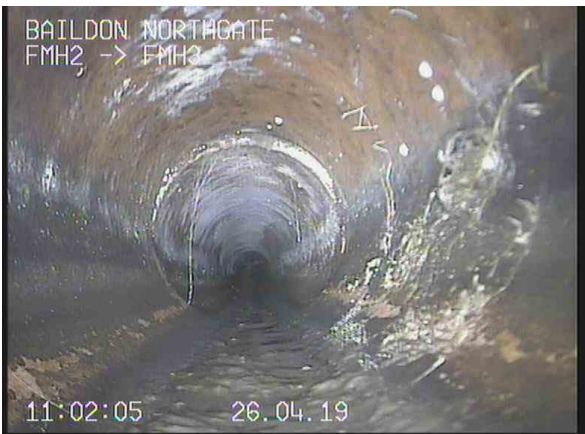
FMH2X_3a386f54-5308-447b-b41d-55cf66ec0d0f_20190426_120210_609.jpg, 00:04:02, 13.92m
 Cracks, multiple from 12 o'clock to 06 o'clock

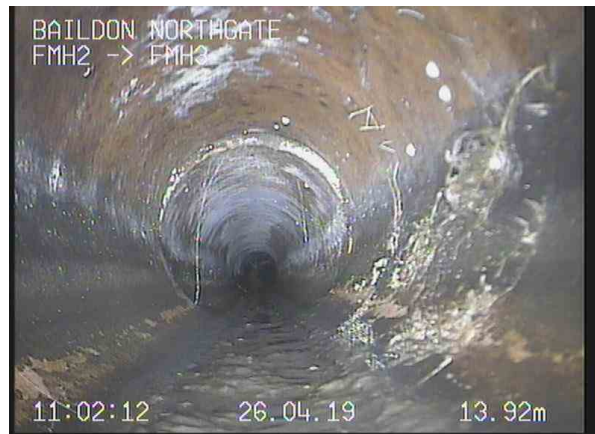
FMH2X_3c1a41a3-a071-49c4-a04a-8a790094ce7b_20190426_120217_308.jpg, 00:04:05, 13.92m
 Roots, tap

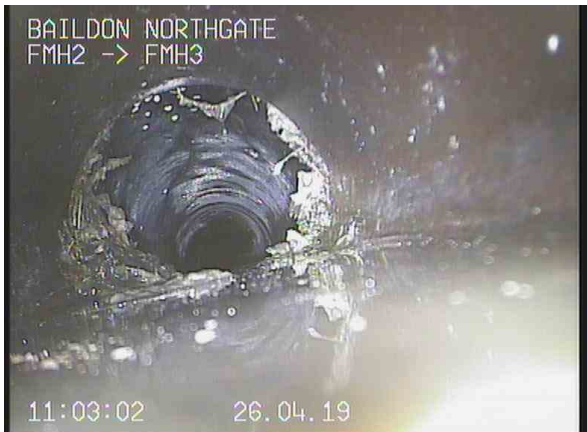
FMH2X_5ccfeccc-0854-4eea-b5c7-b669a8242c0c_20190426_120307_092.jpg, 00:04:46, 16.73m
 Roots, mass, 10% cross-sectional area loss

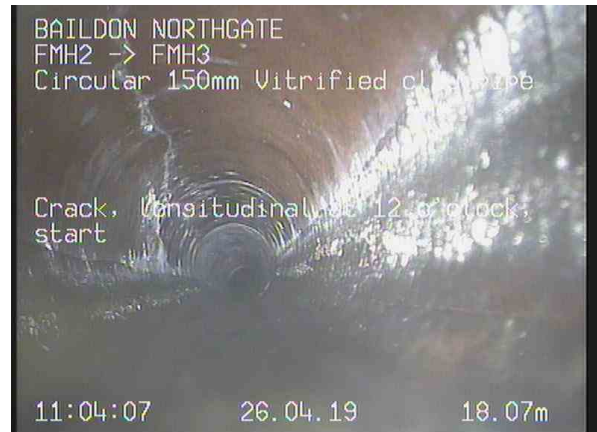
FMH2X_9bb14d8b-ff7f-440a-94cd-94cb75ddfedf_20190426_120412_187.jpg, 00:05:36, 18.07m
 Crack, longitudinal at 12 o'clock, start

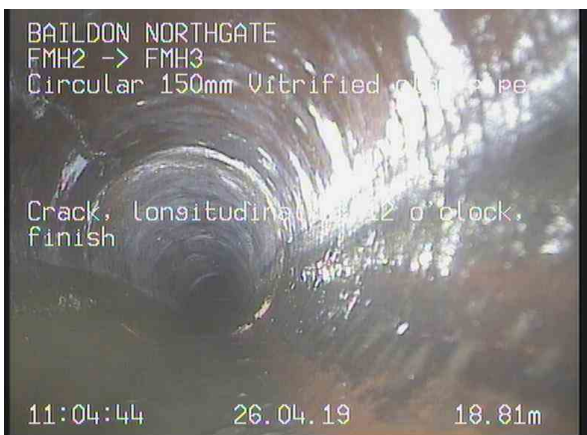
FMH2X_071e6193-0d9f-4261-ba4c-99cdd0e711f2_20190426_120449_518.jpg, 00:06:00, 18.81m
 Crack, longitudinal at 12 o'clock, finish

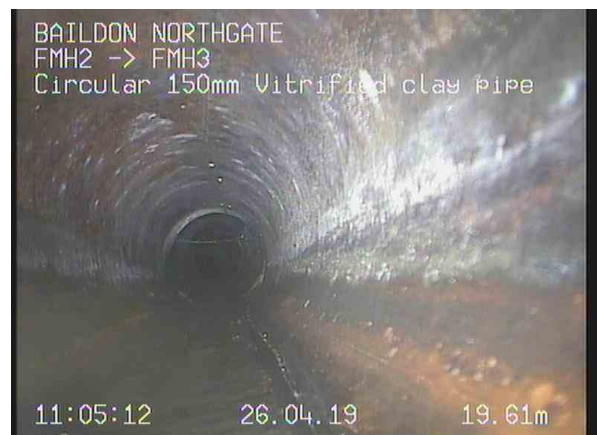
FMH2X_ef0ce60b-3d71-431e-92f8-2f758fc0a796_20190426_120517_313.jpg, 00:06:17, 19.61m
 Crack, longitudinal at 12 o'clock

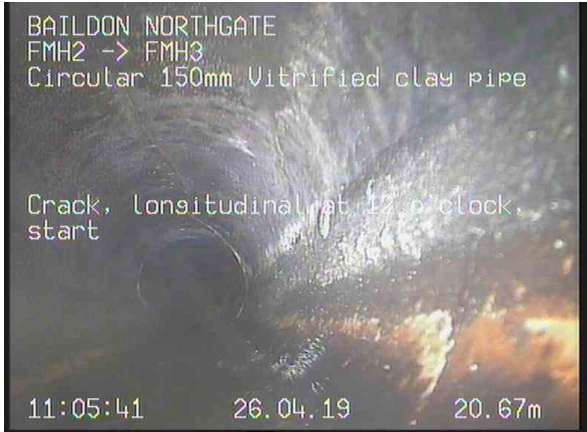
FMH2X_dfac9445-7789-42f9-9c93-5412efc5cae5_20190426_120545_917.jpg, 00:06:37, 20.67m
Crack, longitudinal at 12 o'clock, start

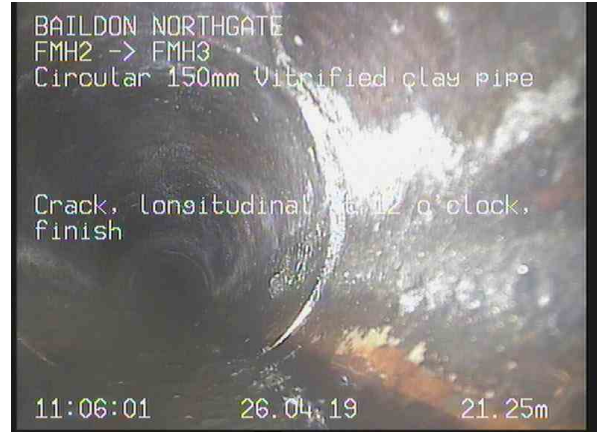
FMH2X_9ed07a0f-87b0-44cc-8256-ec9a3b873836_20190426_120606_383.jpg, 00:06:52, 21.25m
Crack, longitudinal at 12 o'clock, finish

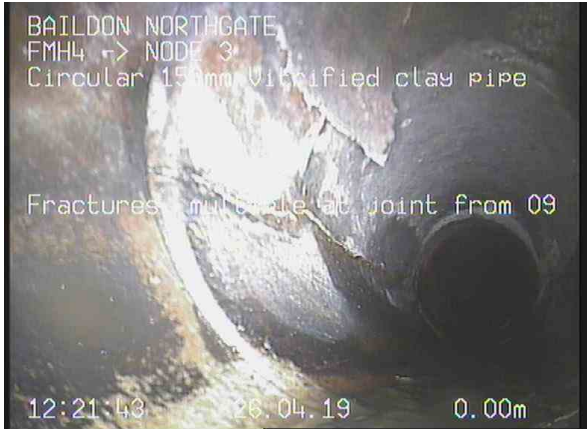
FMH4X_b51d49de-b6f7-40d0-9670-62a95d0827c4_20190426_132148_197.jpg, 00:00:12, 0.10m
 Fractures, multiple at joint from 09 o'clock to 12 o'clock

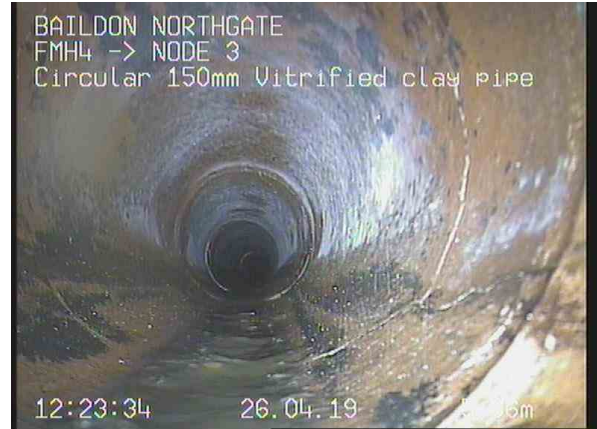
FMH4X_4481a01b-925b-4542-8f02-356f730d7c44_20190426_132339_203.jpg, 00:01:23, 5.86m
 Fractures, multiple from 12 o'clock to 12 o'clock

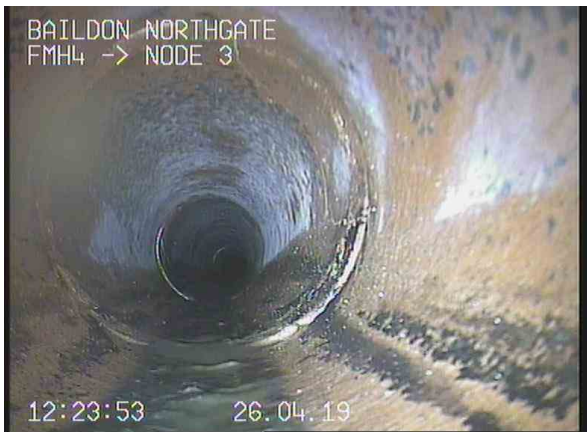
FMH4X_8f6b01eb-ef32-444e-8954-16e455c3c3d2_20190426_132358_283.jpg, 00:01:36, 6.74m
 Cracks, multiple at joint from 12 o'clock to 12 o'clock

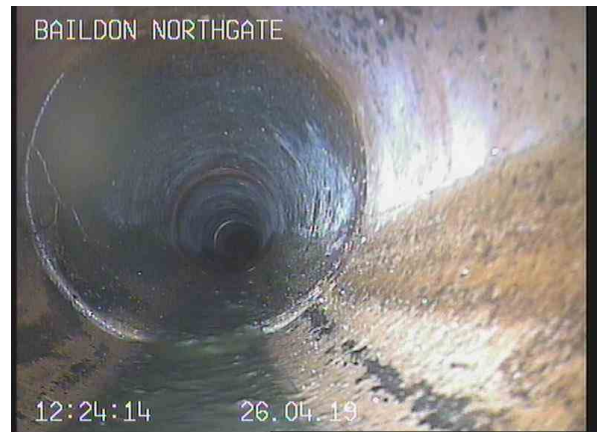
FMH4X_d089155c-a662-418a-8793-6fc2c406b2af_20190426_132419_552.jpg, 00:01:47, 7.30m
 Cracks, multiple at joint from 07 o'clock to 10 o'clock

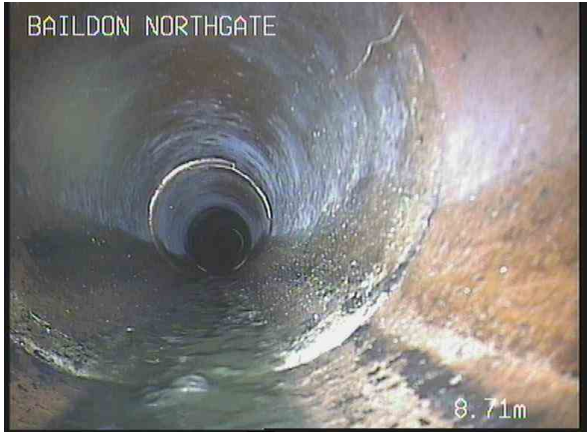
FMH4X_c9c2f2c7-15d8-4bd2-8e2d-85815f63d5a1_20190426_132440_823.jpg, 00:02:02, 8.71m
 Crack, longitudinal at joint at 02 o'clock

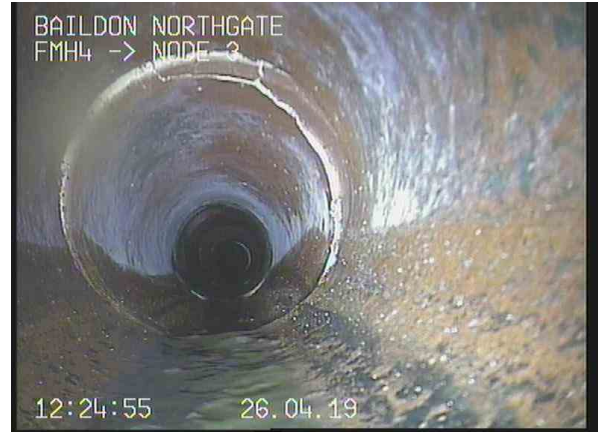
FMH4X_572d9478-faec-4a76-a82a-f8f6e0bfd02f_20190426_132500_617.jpg, 00:02:11, 9.11m
 Cracks, multiple at joint from 11 o'clock to 04 o'clock

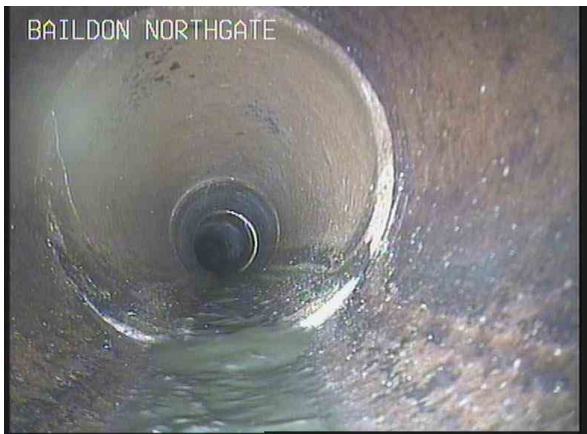
FMH4X_b5e1c4cf-d5b9-4ecb-b6c5-60dc9ea2eb7d_20190426_132538_882.jpg, 00:02:33, 10.44m
 Cracks, multiple at joint from 06 o'clock to 01 o'clock

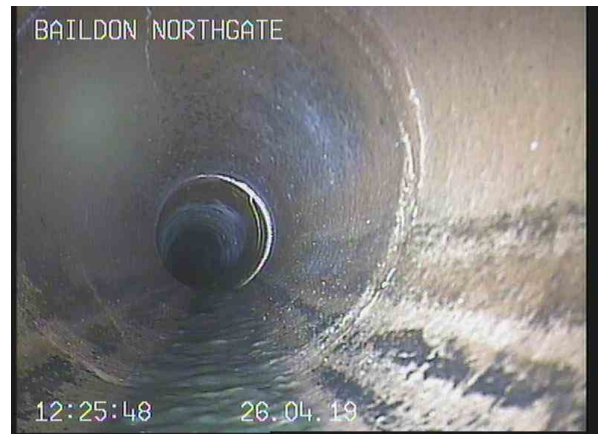
FMH4X_37f6b874-9d80-4475-bc17-4a5e625a9776_20190426_132553_689.jpg, 00:02:42, 10.67m
 Crack, longitudinal at joint at 12 o'clock

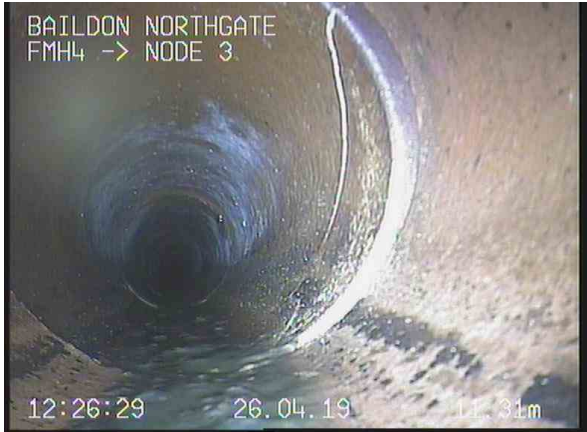
FMH4X_078ea355-74d4-4c82-aa47-65076ffb2622_20190426_132634_287.jpg, 00:03:03, 11.31m
Fracture, circumferential at joint from 01 o'clock to 06 o'clock

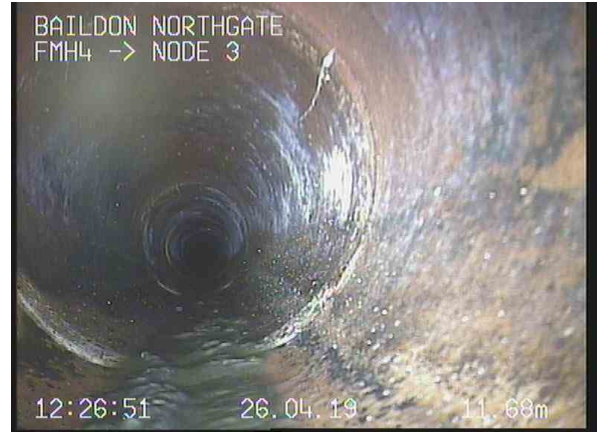
FMH4X_7ddf25d9-c04a-46e7-88d6-8f996d0a5c22_20190426_132656_057.jpg, 00:03:16, 11.68m
Crack, longitudinal at joint at 02 o'clock

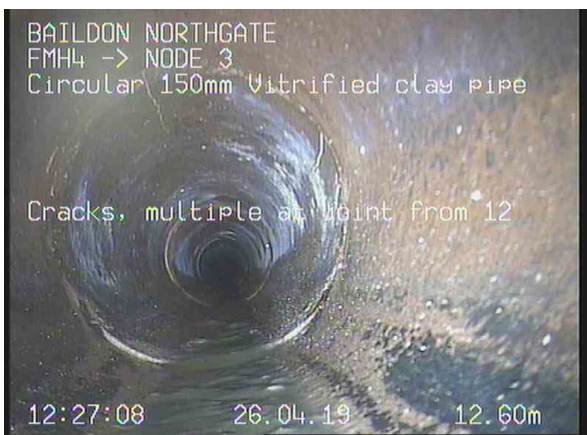
FMH4X_37a5d84a-854c-404b-a321-1172a2489fd6_20190426_132713_349.jpg, 00:03:26, 12.60m
Cracks, multiple at joint from 12 o'clock to 12 o'clock

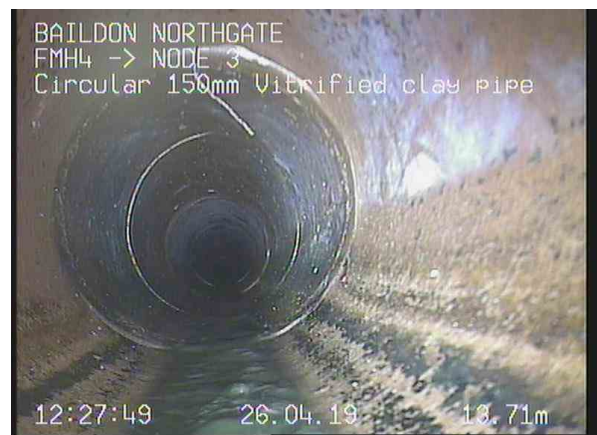
FMH4X_836c0e56-3f37-43fa-bdf4-4936ccdd71c1_20190426_132754_154.jpg, 00:03:55, 13.71m
Fractures, multiple at joint from 12 o'clock to 12 o'clock

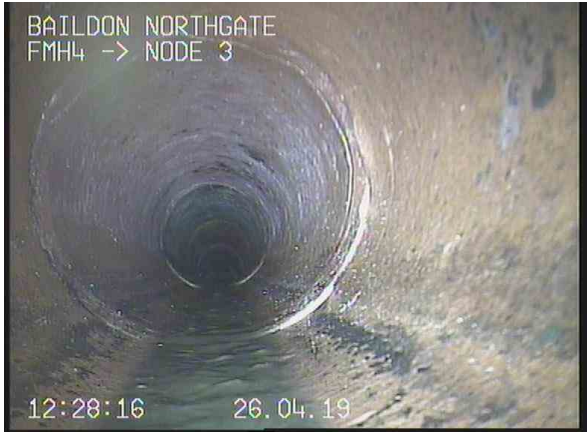
FMH4X_856a3b63-4c27-4a91-95e7-18b0a7d1567e_20190426_132821_789.jpg, 00:04:14, 14.45m
 Crack, circumferential at joint from 12 o'clock to 12 o'clock

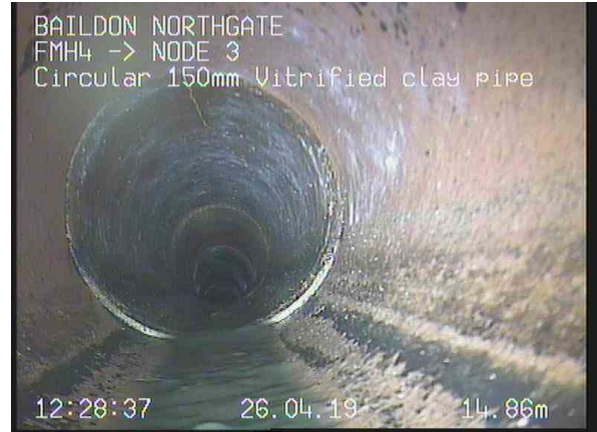
FMH4X_94a441cb-1ccb-48af-b4db-29b1968e9864_20190426_132842_470.jpg, 00:04:27, 14.86m
 Crack, longitudinal at joint at 12 o'clock

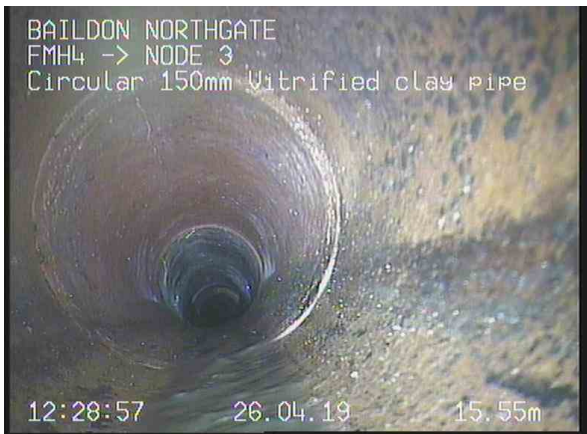
FMH4X_5c6cca82-9a4d-47a1-baeb-070ccae904a1_20190426_132902_294.jpg, 00:04:41, 15.55m
 Crack, longitudinal at joint at 12 o'clock

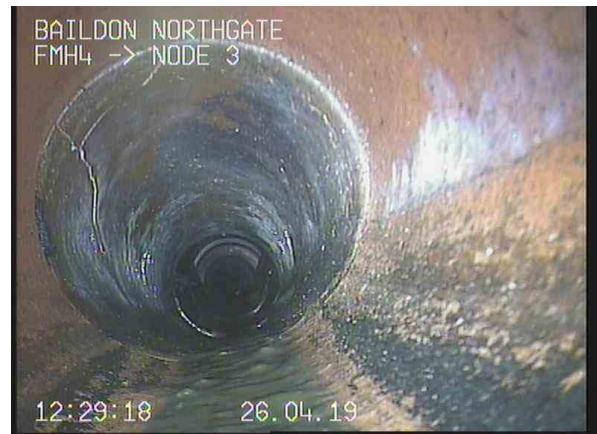
FMH4X_f9ab6ddc-9c77-48c3-b4e5-4af9b806b68f_20190426_132923_052.jpg, 00:04:53, 16.09m
 Fractures, multiple at joint from 06 o'clock to 12 o'clock

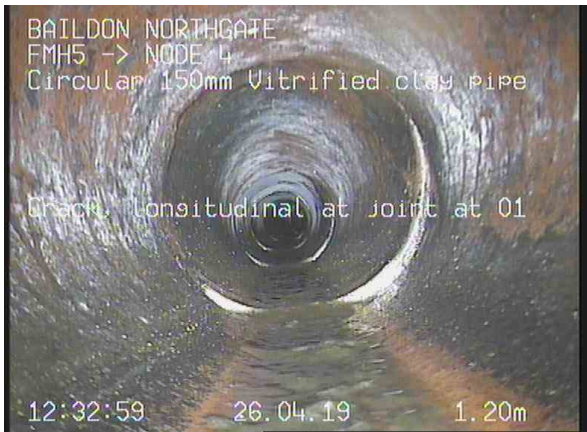
FMH5X_6d62e0e6-e35b-4c66-8896-8f3e35199cab_20190426_133304_557.jpg, 00:00:37, 1.19m
 Crack, longitudinal at joint at 01 o'clock

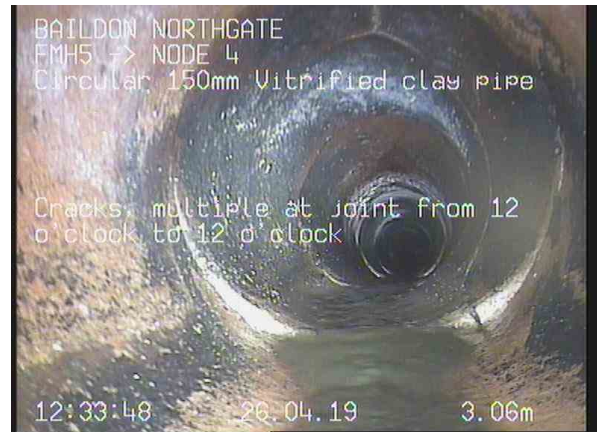
FMH5X_8c712ea2-c648-4554-b87e-865940ebdf75_20190426_133353_669.jpg, 00:01:13, 3.06m
 Cracks, multiple at joint from 12 o'clock to 12 o'clock

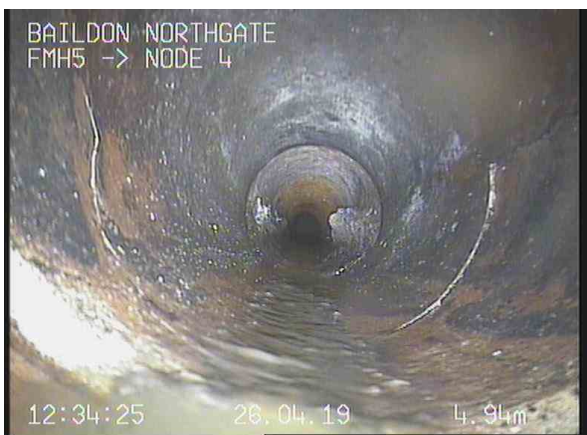
FMH5X_05e85977-87fd-4c18-97dc-d1236d17314d_20190426_133430_527.jpg, 00:01:41, 4.94m
 Fractures, multiple from 03 o'clock to 09 o'clock

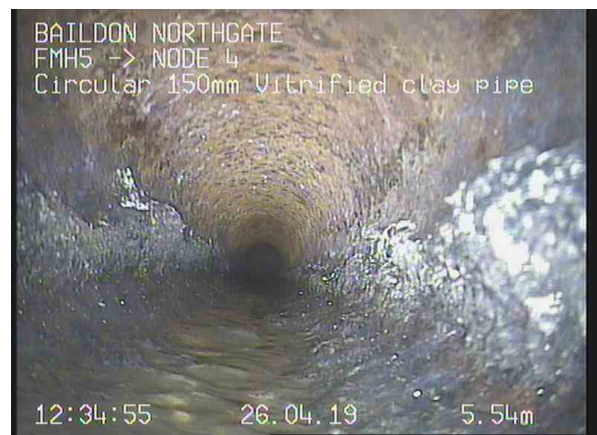
FMH5X_481421fb-d2cb-4509-8f93-f3d2439639d6_20190426_133500_046.jpg, 00:01:54, 5.54m
 Attached deposits, grease from 03 o'clock to 09 o'clock, 10% cross-sectional area loss

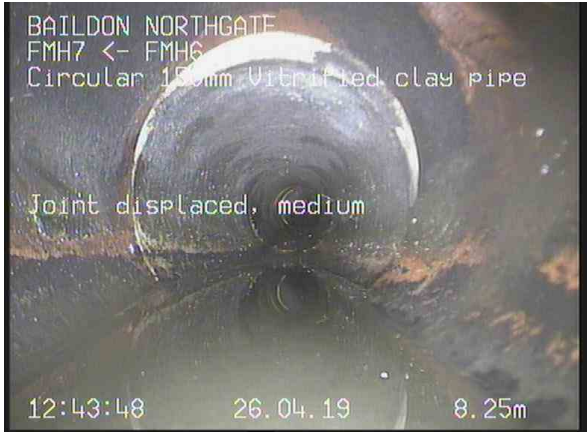
FMH7X_773b61af-2212-40eb-8553-b481a60c6293_20190426_134353_603.jpg, 00:01:36, 8.25m
Joint displaced, medium

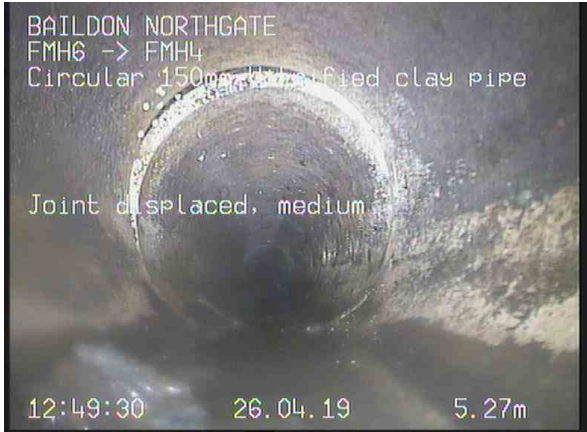
FMH6X_73c610c7-1ed0-4ca8-bae9-efec823b5e9a_20190426
_134935_867.jpg, 00:00:59, 5.27m
Joint displaced, medium

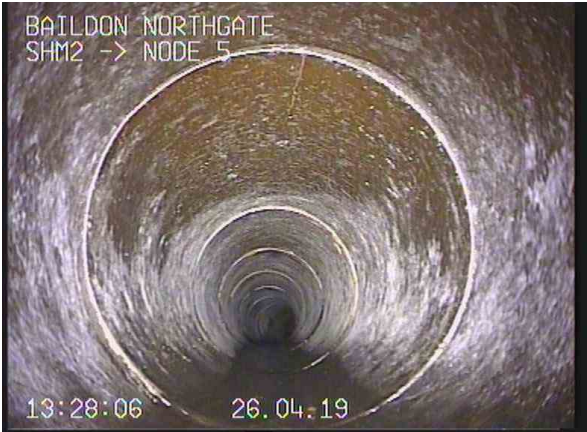
SHM2X_b39c3297-7e97-4427-a986-ace9cd0ff24_20190426_142811_657.jpg, 00:00:33, 1.97m
 Crack, longitudinal at joint at 12 o'clock

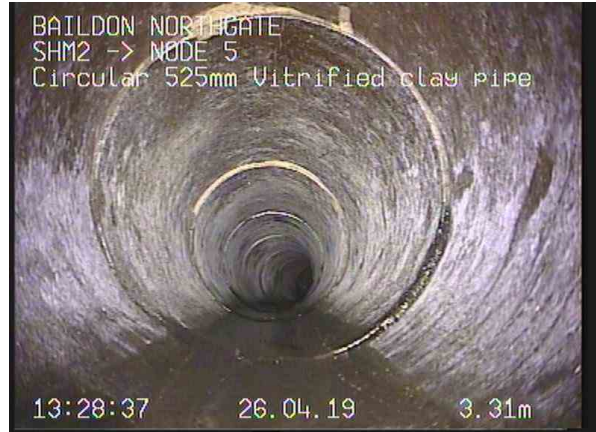
SHM2X_74e081c4-76cd-4b14-bffb-17f9eee899d6_20190426_142842_223.jpg, 00:00:54, 3.31m
 Crack, longitudinal at 12 o'clock

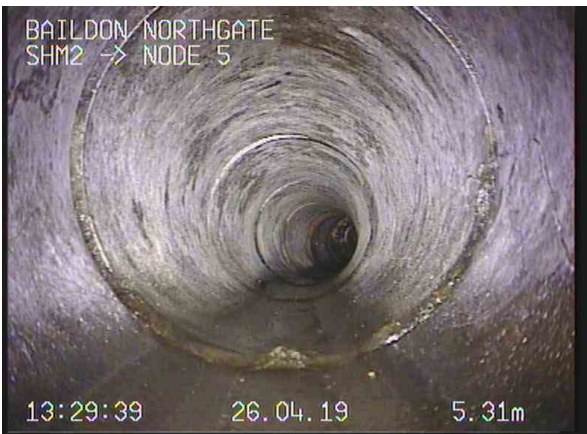
SHM2X_bdb853b0-9749-4c59-b2c0-6666ebbc300d_20190426_142945_169.jpg, 00:01:28, 5.31m
 Crack, circumferential at joint from 03 o'clock to 05 o'clock

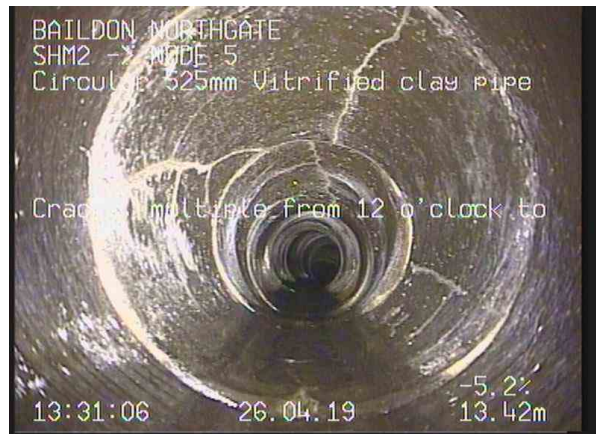
SHM2X_76e72302-4cb0-4400-ac83-4a4521799b0b_20190426_143111_219.jpg, 00:02:40, 13.42m
 Cracks, multiple from 12 o'clock to 12 o'clock, start

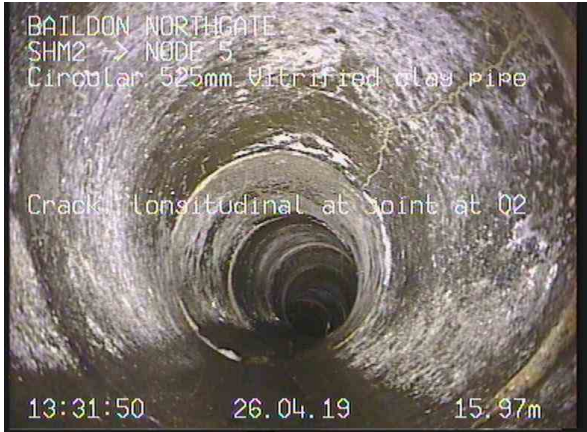
SHM2X_60a6810e-aed7-482a-b788-89612660317b_20190426_143155_865.jpg, 00:03:13, 15.97m
 Crack, longitudinal at joint at 02 o'clock

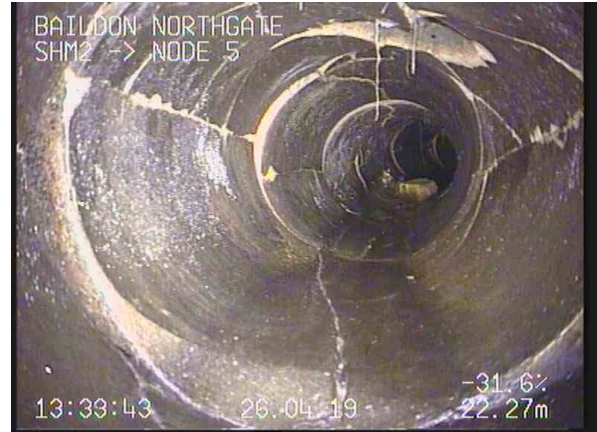
SHM2X_6cbad2c2-0f0c-41bb-9652-0fb188b4c837_20190426_143348_461.jpg, 00:04:48, 22.24m
 Hole in drain or sewer from 11 o'clock to 01 o'clock

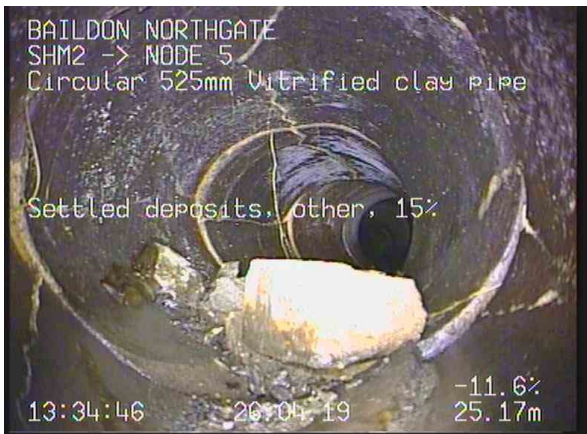
SHM2X_e59c87d4-d43d-4762-8906-aa34cd9aa7a8_20190426_143451_842.jpg, 00:05:27, 25.17m
 Settled deposits, other, 15% cross-sectional area loss

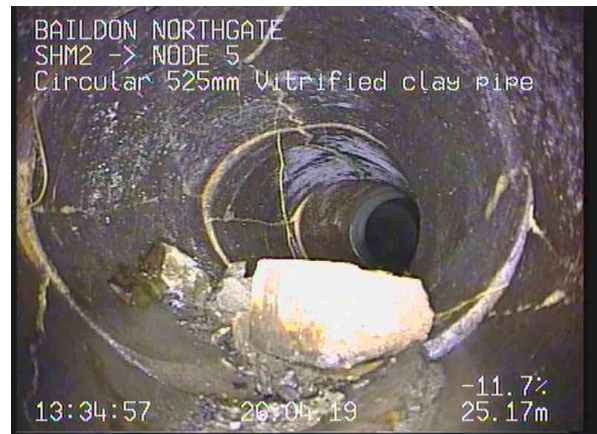
SHM2X_2c0e3a17-0613-405e-b321-cad5f463677d_20190426_143502_372.jpg, 00:05:32, 25.17m
 Cracks, multiple from 12 o'clock to 12 o'clock, finish

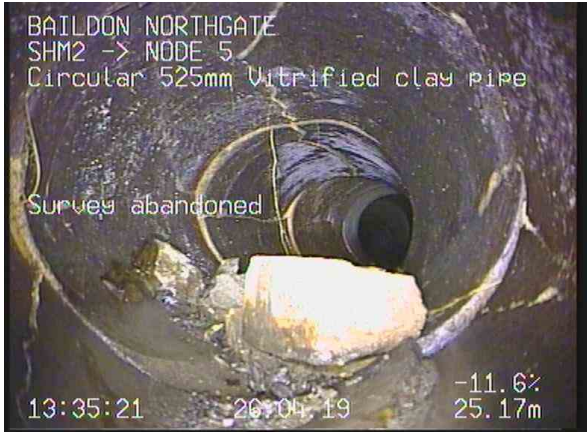
25.17	F02	Cracks, multiple from 12 o'clock to 12 o'clock, finish	3	
	25.18	SA	Survey abandoned: UNABLE TO PASS STONE IN LINE		
	NODE 5 Depth:

SHM2X_b7b6363a-ade6-4a04-9105-c1498c938bf8_20190426_143526_569.jpg, 00:05:36, 25.18m
Survey abandoned

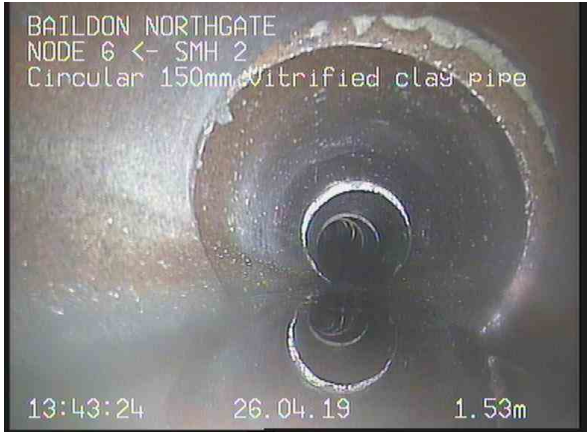
NODE
 6X_9da08712-1f0e-4fee-91a5-18e7db945014_20190426_144
 329_343.jpg, 00:00:38, 1.53m
 Joint displaced, large

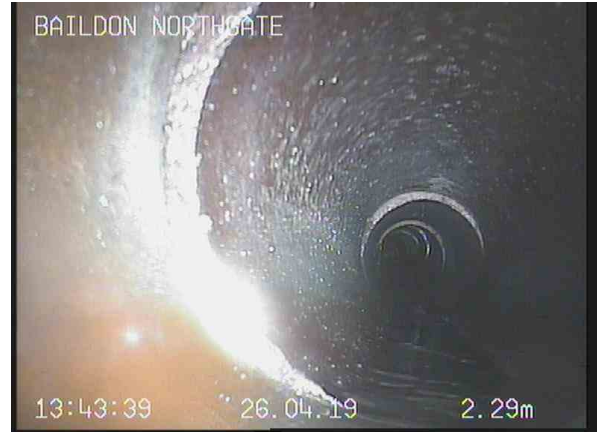
NODE
 6X_e776eb2f-4ddb-4987-af8b-8e59e9d2e7ac_20190426_144
 344_749.jpg, 00:00:50, 2.29m
 Joint displaced, medium

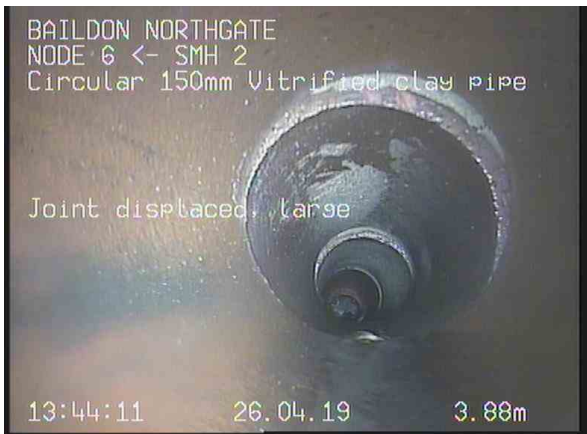
NODE
 6X_433d8569-b191-460b-9036-0d176aa812a9_20190426_14
 4416_603.jpg, 00:01:08, 3.88m
 Joint displaced, large

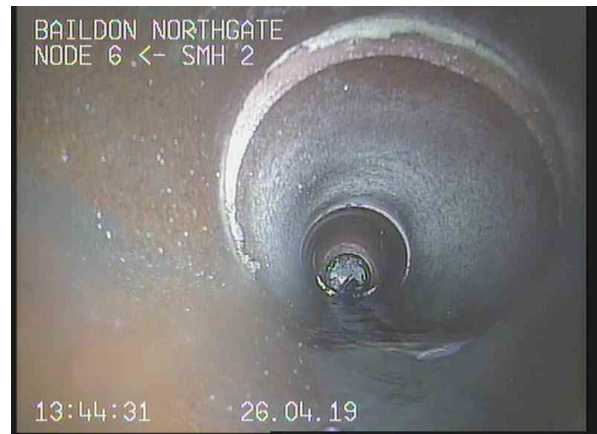
NODE
 6X_ea13d6de-62ea-4f21-a3c1-8d536d0f3a64_20190426_144
 436_539.jpg, 00:01:26, 4.65m
 Joint displaced, medium
