Project Name: HollyCroft Construction LTD -Baildon Mills -PJ00332160 -
26-04-19

Project Date: 26/04/2019

Project Standard: MSCC5 Sewers & Drainage GB (SRM5 Scoring)

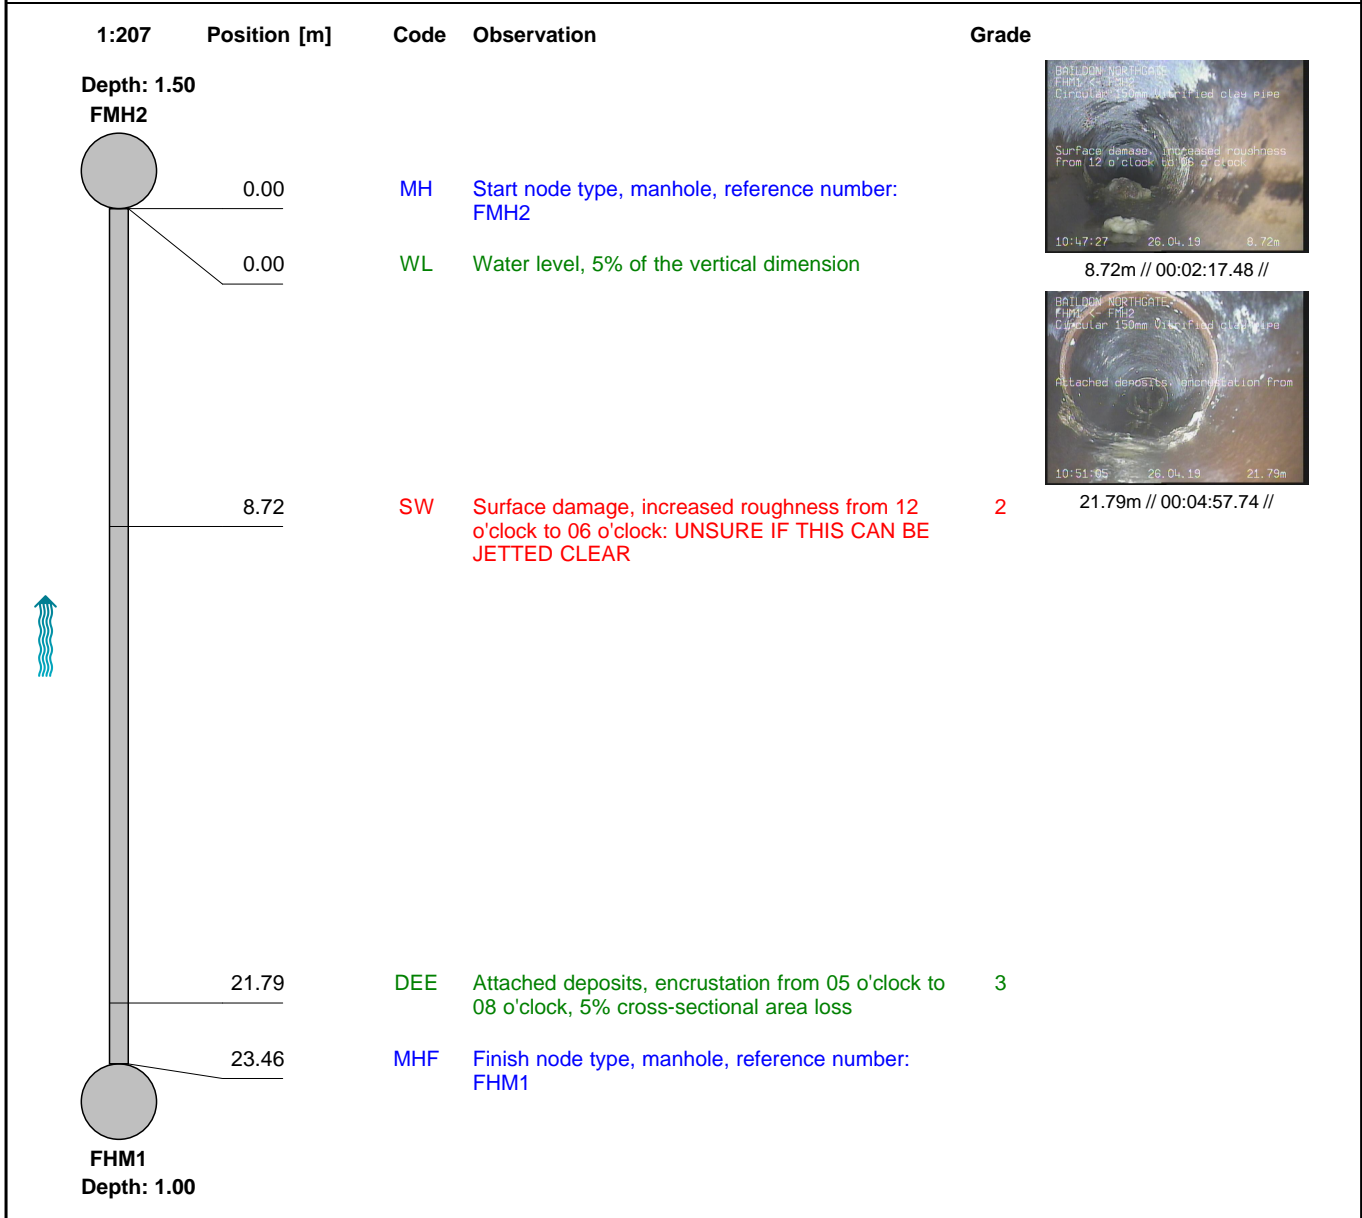
Town or Village: BAILDON	Insp Dir: FMH2 << FHM1	US MH: FHM1
Road: Northgate	Inspected Length: 23.46 m	US Depth: 1.000 m
Location: Under a permanent building	Total Length: 23.46 m	DS MH: FMH2
Surface Type: Concrete Footway	Pipe Length: 0.00 m	DS Depth: 1.500 m
Use: Foul	Pipe Shape: Circular	
Type of Pipe: Gravity drain/sewer	Height / Width: 150 mm	
Year Constructed:	Pipe Material: Vitrified clay pipe	
Inspection Purpose: Sample survey to determine asset condition of a sewer system	Lining Type: None	
Flow Control: No flow control	Lining Material: None

Structural Defects					Construction Features				
Service & Operational Observations					Miscellaneous Features				
STR No. Def	STR Peak	STR Mean	STR Total	STR Grade	SER No. Def	SER Peak	SER Mean	SER Total	SER Grade
1	10.0	0.4	10.0	2.0	1	2.0	0.1	2.0	3.0

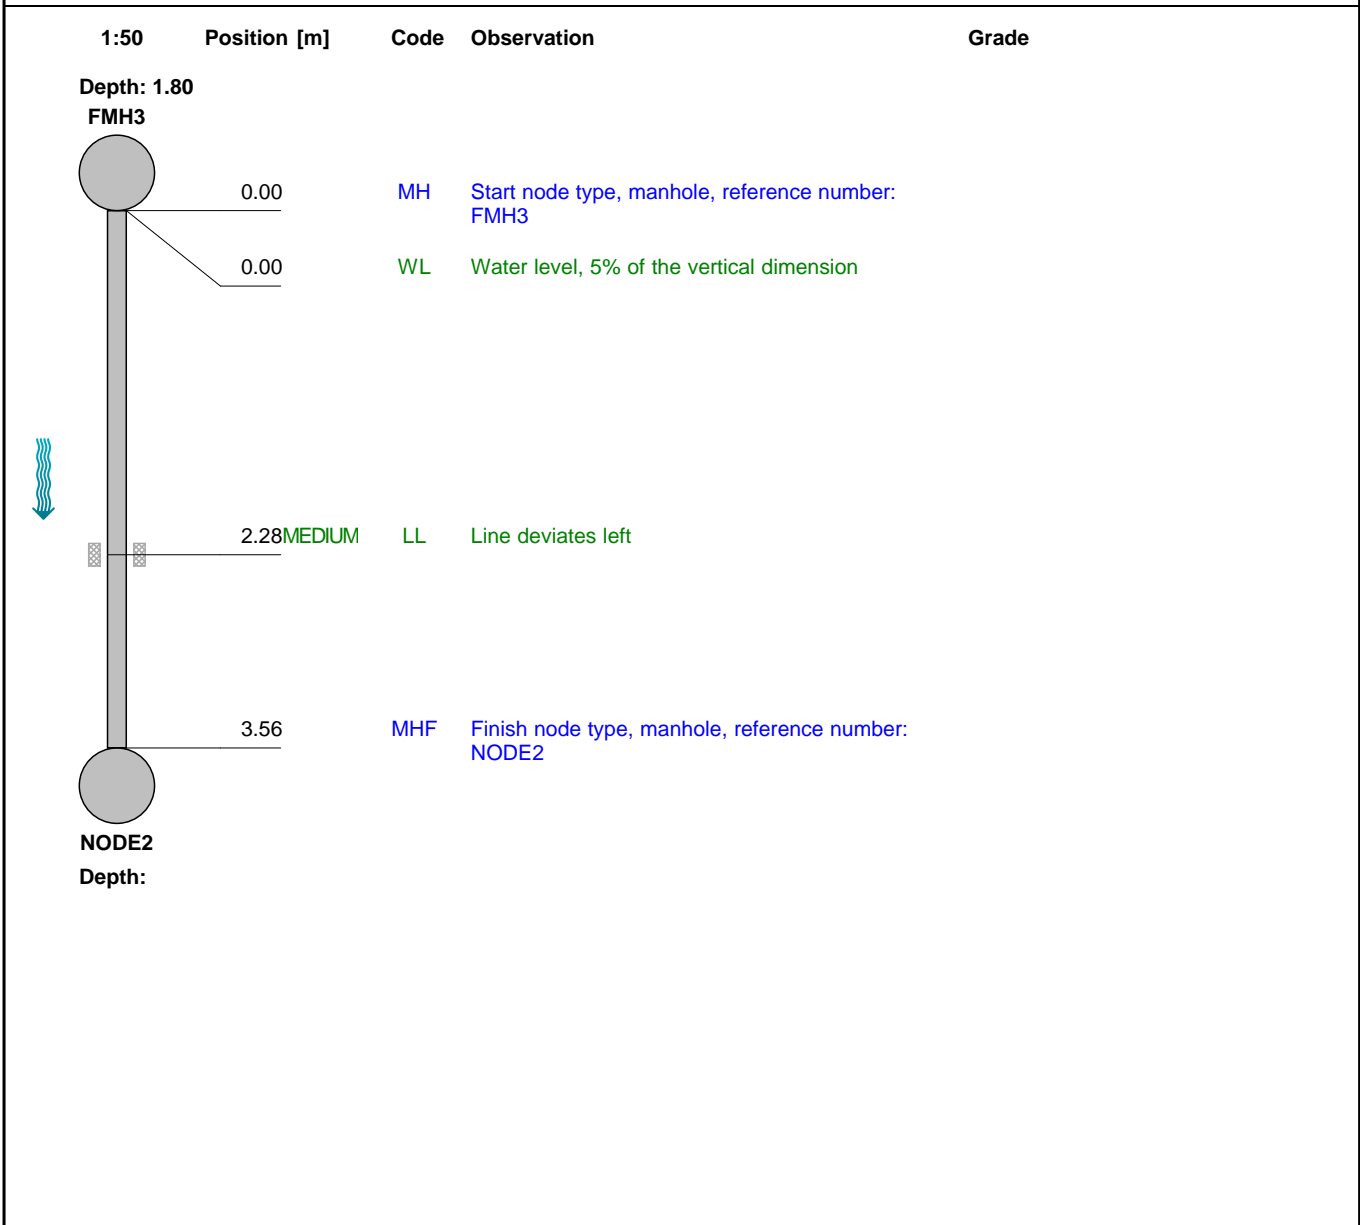
Comment: **OUTFALLS INTO FMH7**
 Recommendation:

Structural Defects					Construction Features				
Service & Operational Observations					Miscellaneous Features				
STR No. Def	STR Peak	STR Mean	STR Total	STR Grade	SER No. Def	SER Peak	SER Mean	SER Total	SER Grade
0	0.0	0.0	0.0	1.0	0	0.0	0.0	0.0	1.0

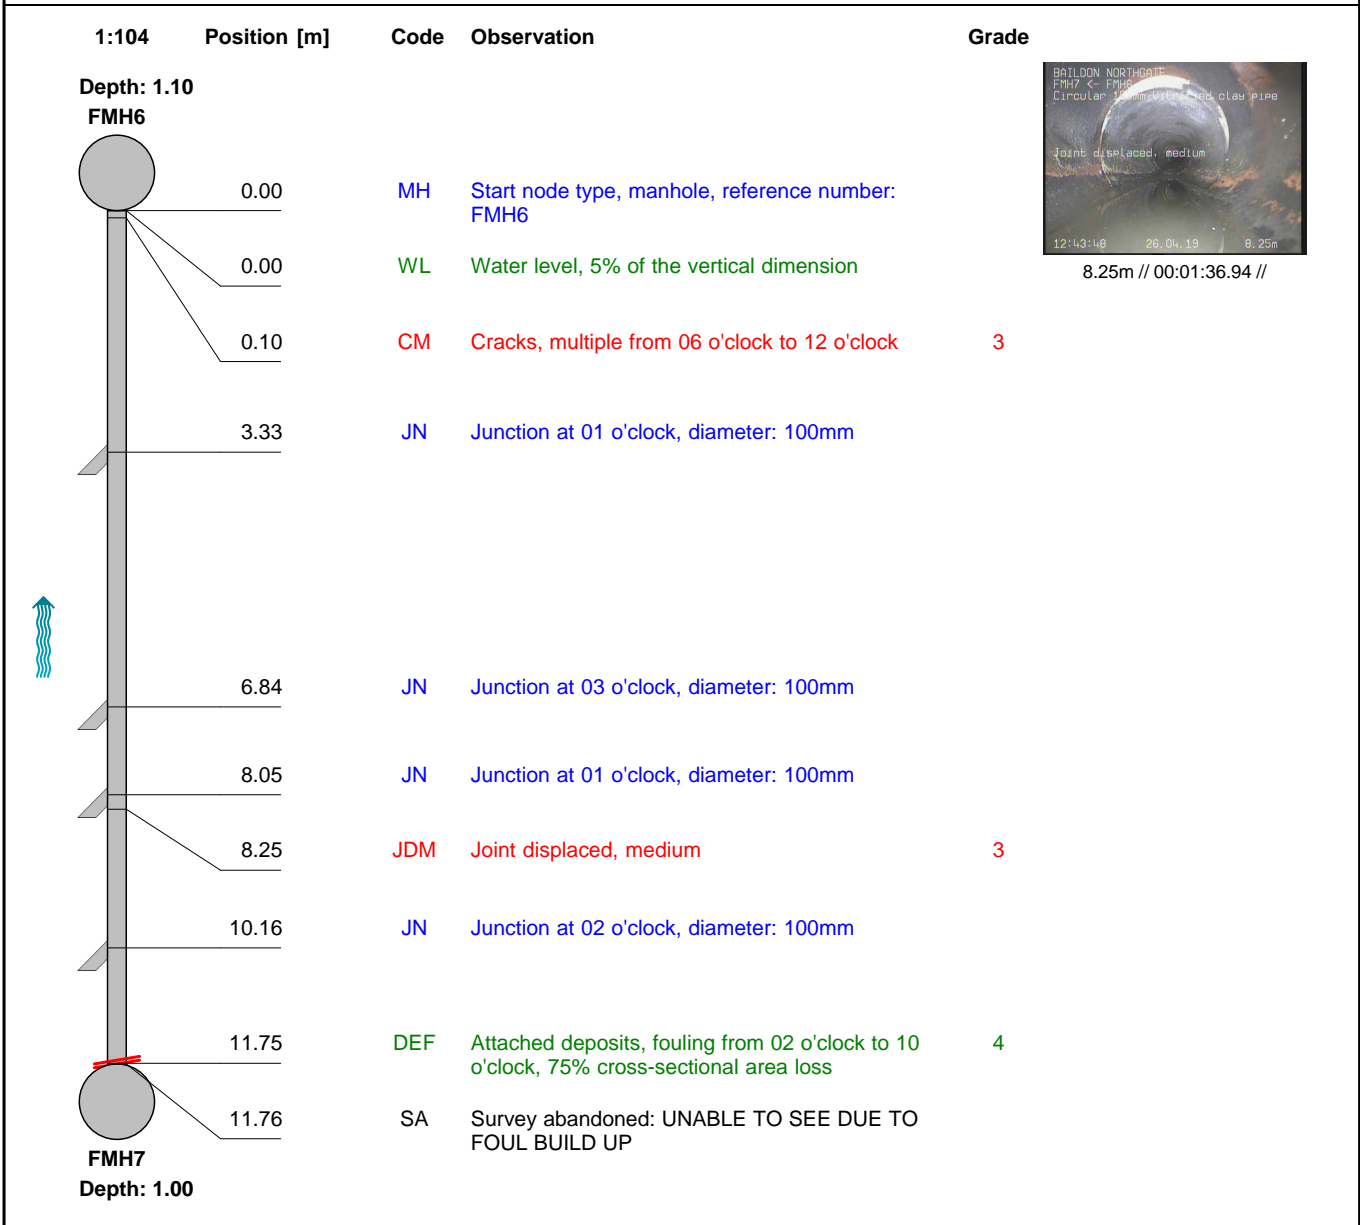
Structural Defects					Construction Features				
Service & Operational Observations					Miscellaneous Features				
STR No. Def	STR Peak	STR Mean	STR Total	STR Grade	SER No. Def	SER Peak	SER Mean	SER Total	SER Grade
2	40.0	41.0	41.0	3.0	3	5.0	8.0	8.0	4.0

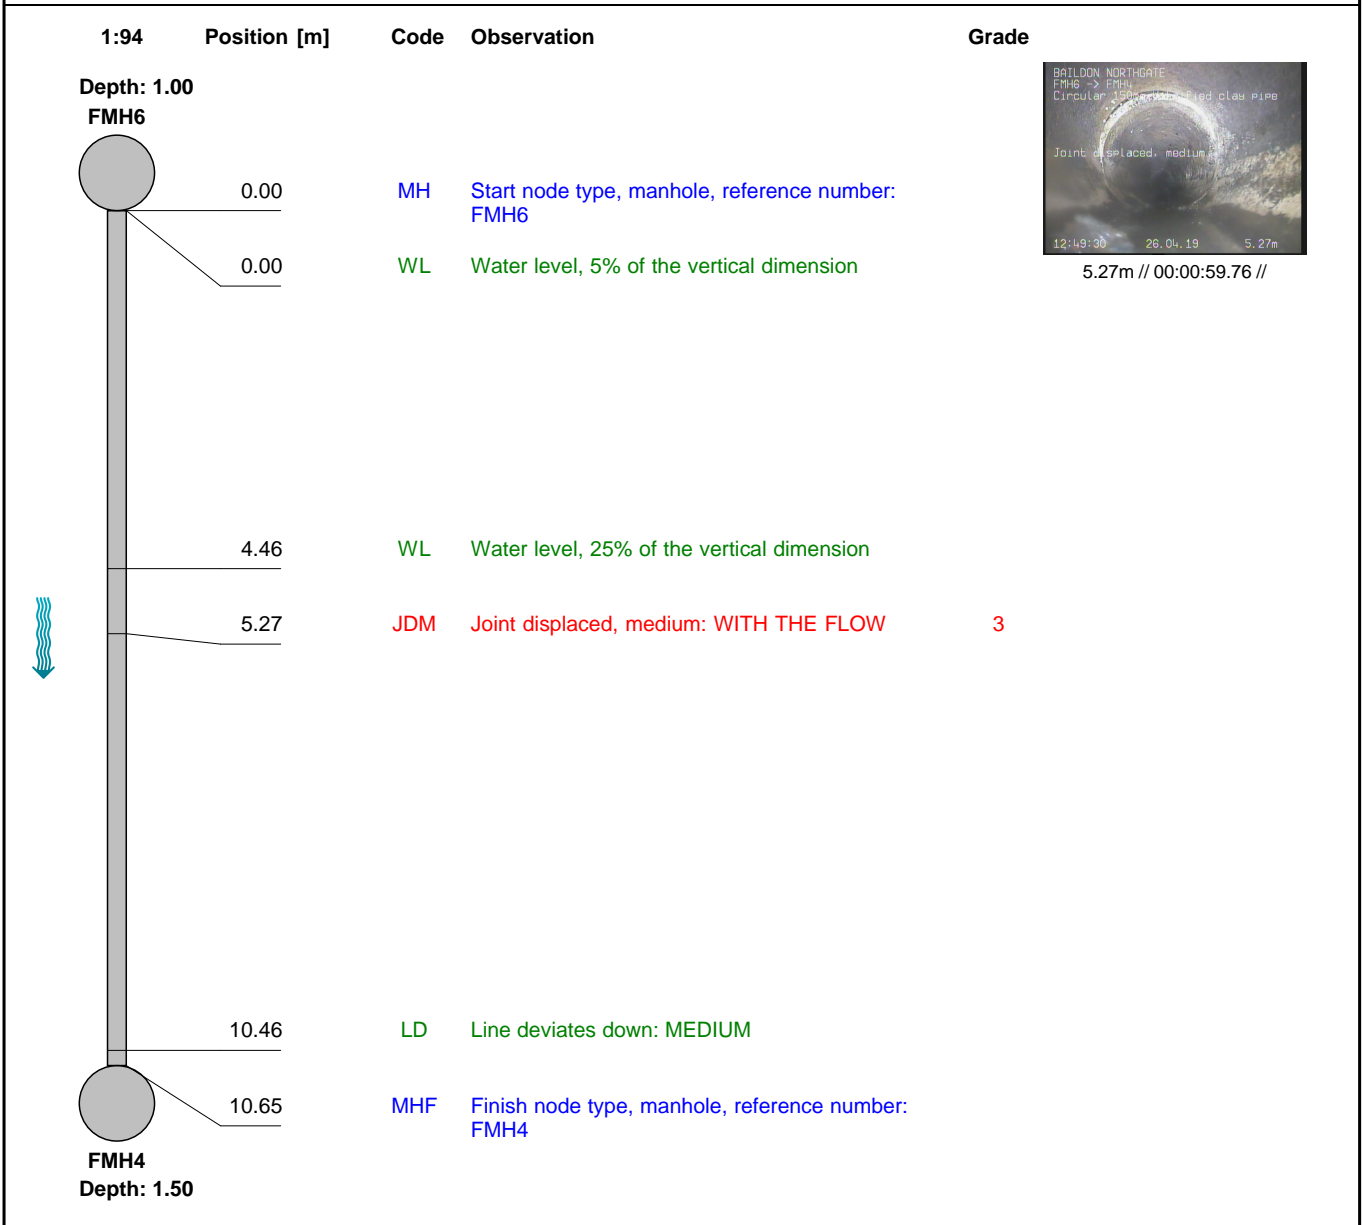
5.27m // 00:00:59.76 //

Structural Defects					Construction Features				
Service & Operational Observations					Miscellaneous Features				
STR No. Def	STR Peak	STR Mean	STR Total	STR Grade	SER No. Def	SER Peak	SER Mean	SER Total	SER Grade
1	1.0	0.1	1.0	1.0	1	2.0	0.2	2.0	3.0

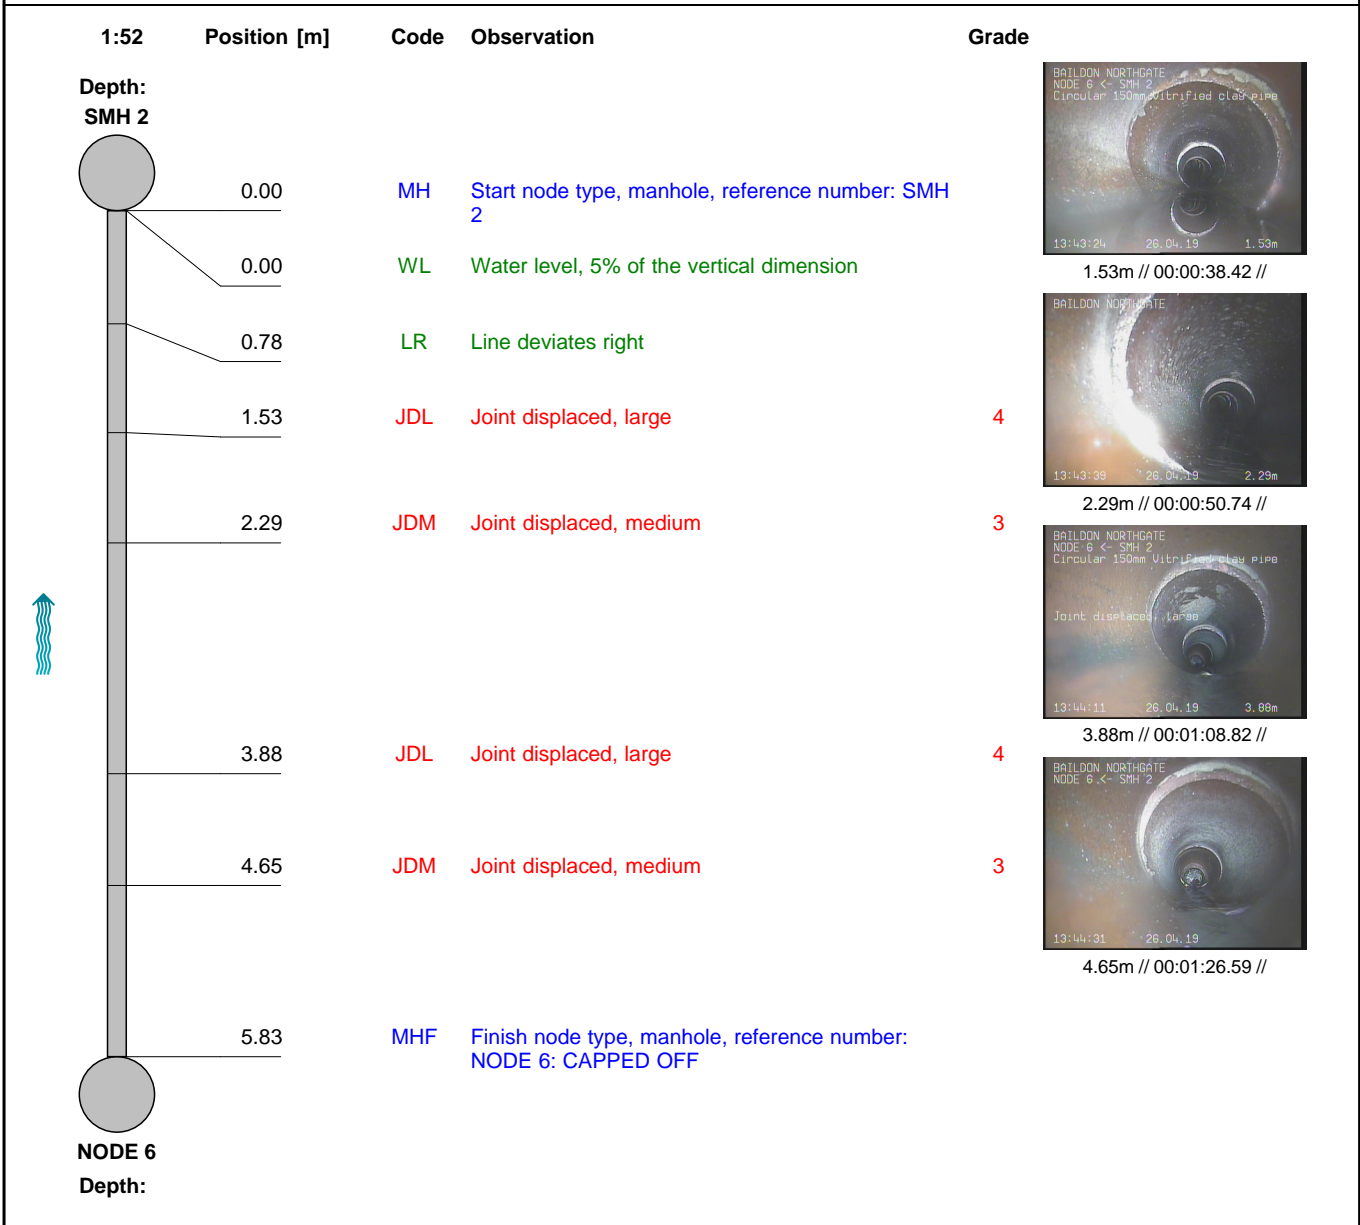
Town or Village: BAILDON	Insp Dir: SMH 2 << NODE 6	US MH: NODE 6
Road: Northgate	Inspected Length: 5.83 m	US Depth:
Location: Under a permanent building	Total Length: 5.83 m	DS MH: SMH 2
Surface Type: Concrete Footway	Pipe Length: 0.00 m	DS Depth:
Use: Surface water	Pipe Shape: Circular	
Type of Pipe: Gravity drain/sewer	Height / Width: 150 mm	
Year Constructed:	Pipe Material: Vitrified clay pipe	
Inspection Purpose: Sample survey to determine asset condition of a sewer system	Lining Type: None	
Flow Control: No flow control	Lining Material: None

Structural Defects					Construction Features				
Service & Operational Observations					Miscellaneous Features				
STR No. Def	STR Peak	STR Mean	STR Total	STR Grade	SER No. Def	SER Peak	SER Mean	SER Total	SER Grade
4	2.0	1.0	6.0	1.0	4	5.0	2.4	14.0	4.0
