# Technical Due Diligence Report

2810 BAILDON MILLS, BRADFORD BD17 6JY

JUNE 2016

KMRE GROUP LIMITED

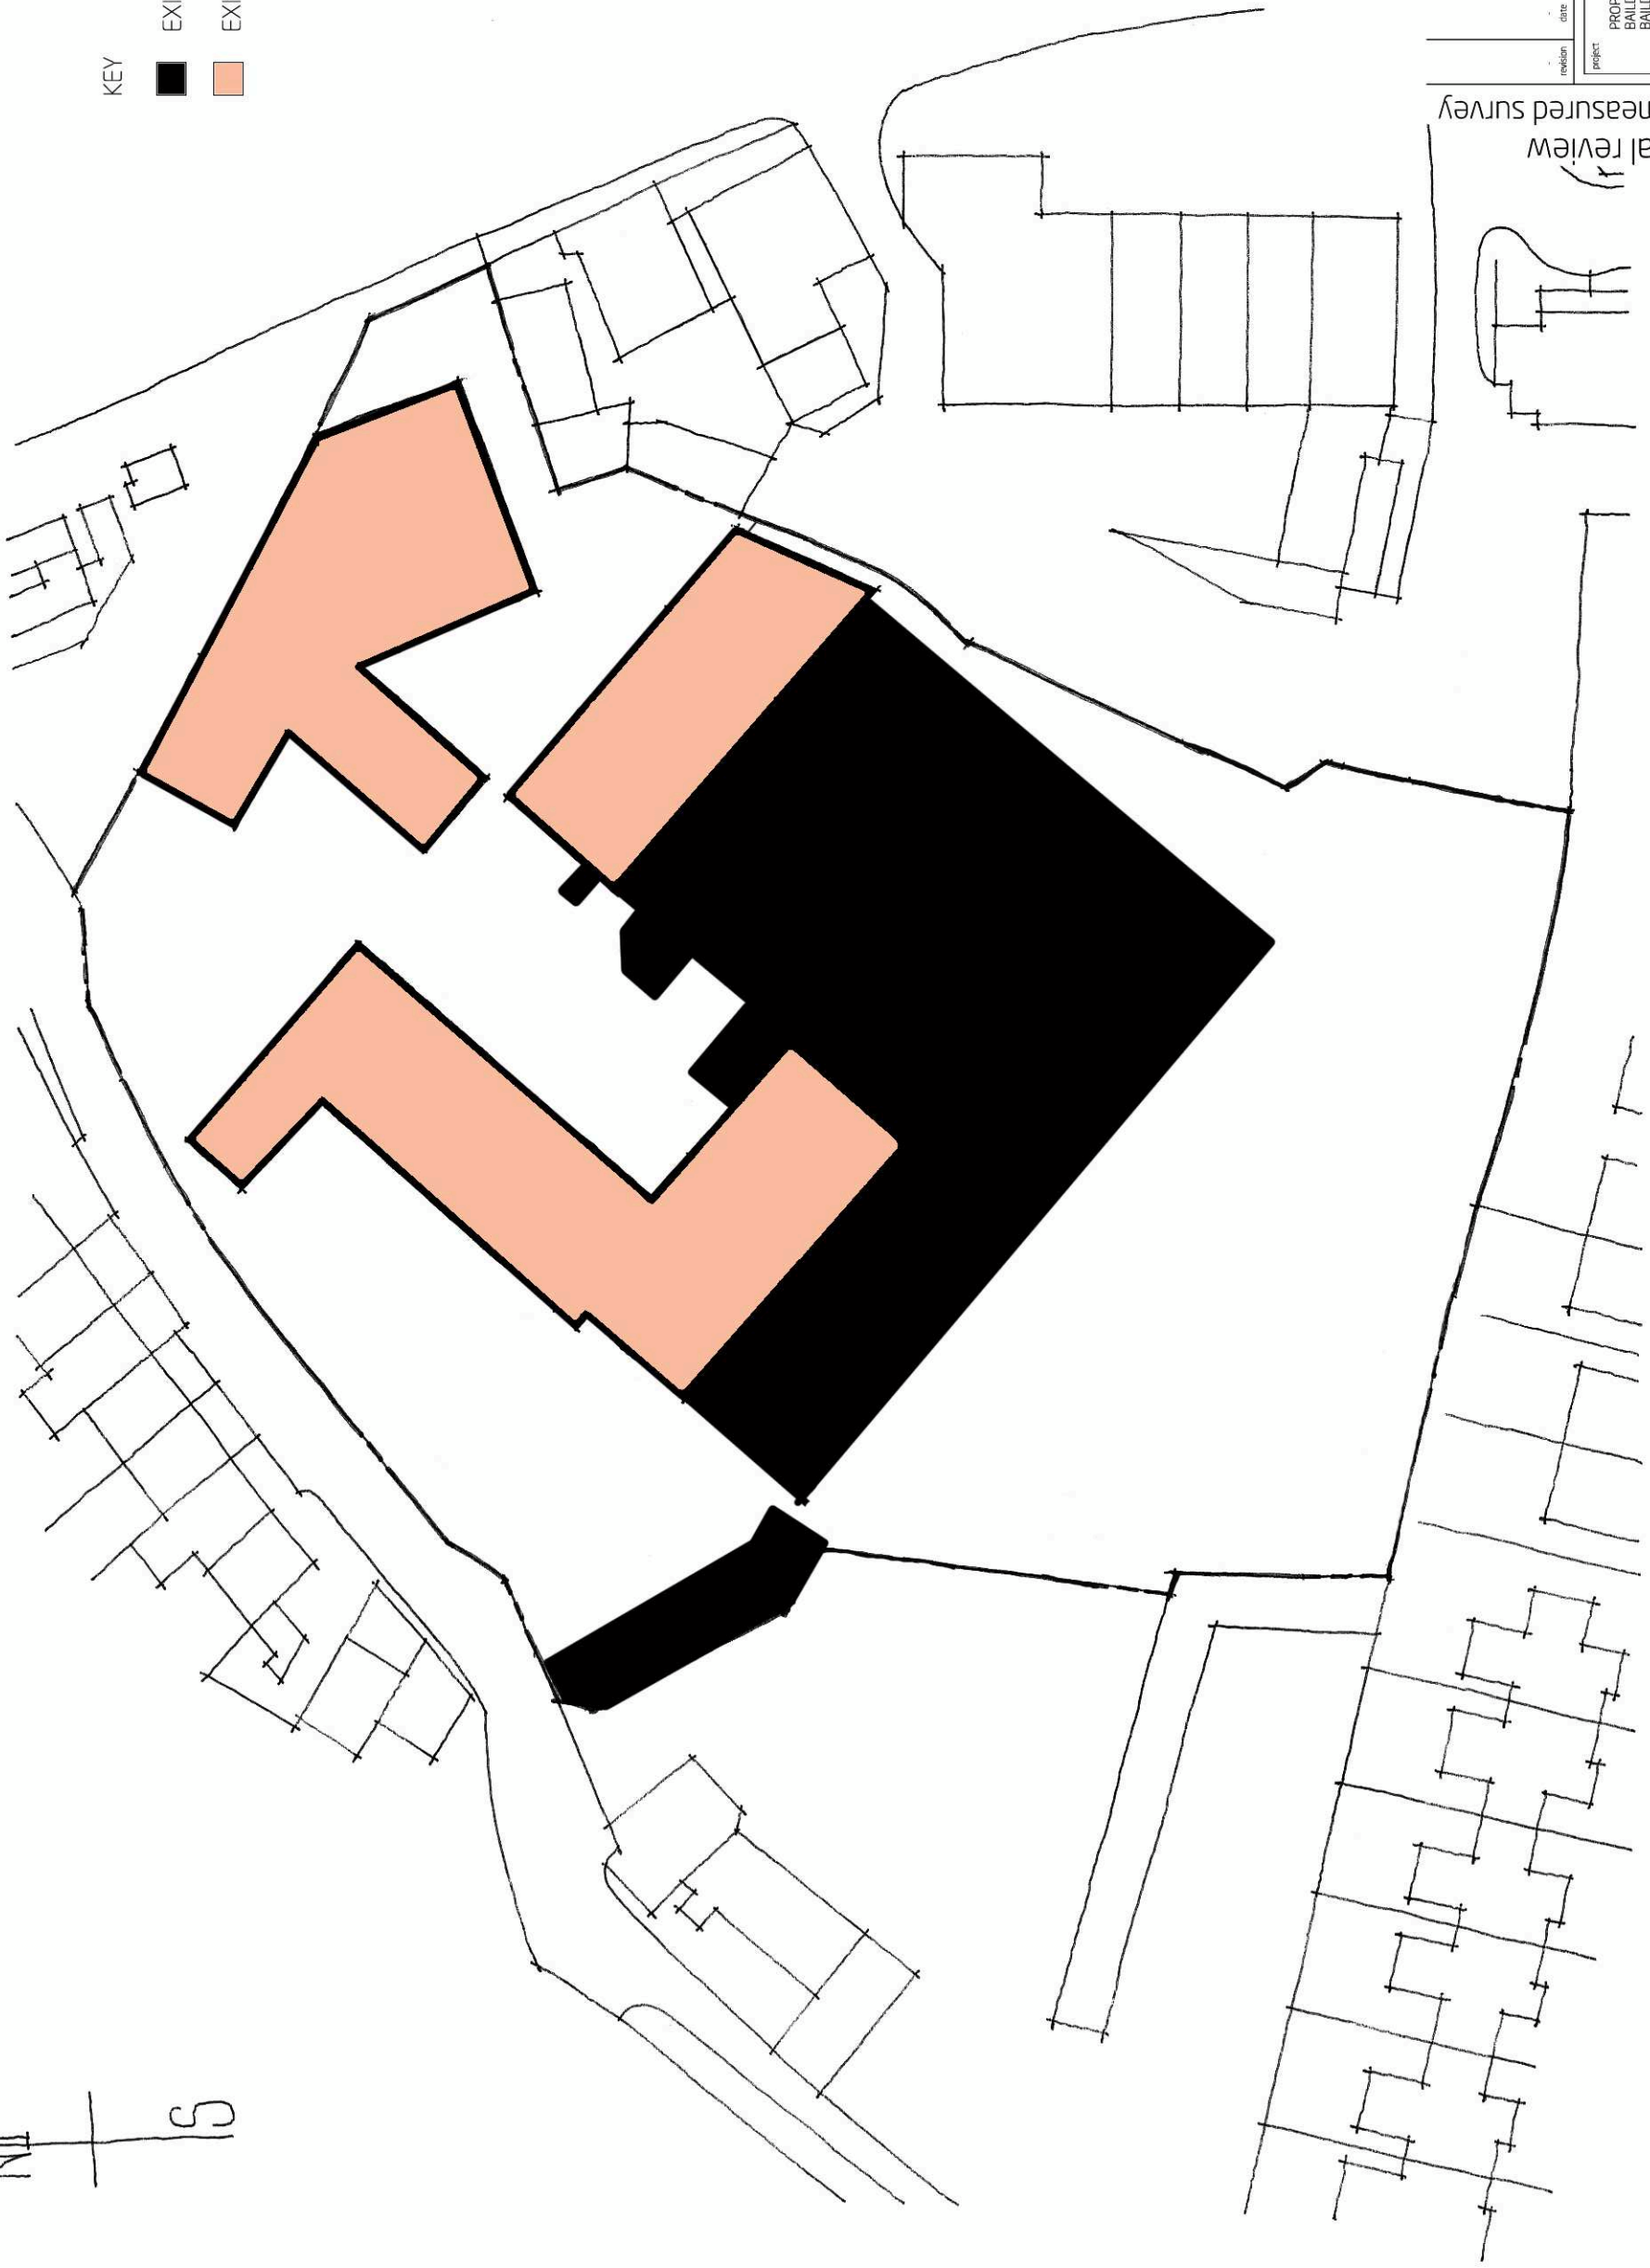
revision	date	content	details
<p>PROJECT: PROPOSED RESIDENTIAL BAILDON MILLS BAILDON, BRADFORD</p>			
<p>CLIENT: KMRE GROUP</p>			
<p>TITLE: SITE ZONING PLAN DEMOLITION</p>			
DATE: 02.16	SCALE: 1:500@A3	DRAWN: SAN	CHECKED:
DRAWING NUMBER: 2810-0-005-

EXISTING BUILDINGS TO BE DEMOLISHED

EXISTING BUILDINGS RETAINED

SKETCH  
subject to structural review  
subject to accurate measured survey

In accordance with your instructions we have undertaken a visual building survey of the above property pursuant to your intention to acquire a freehold interest in the property. Following the acquisition of the site, and subject to the necessary statutory approvals, it is understood that you propose to convert the original mill buildings into residential units. It is also understood that it is your intention to demolish the more recently constructed buildings found toward the rear of the site, as identified on the plan shown within Appendix B
